## 5 DRAINAGE PROBLEMS AND REMEDIAL MEASURES 1941-1967

### 5.1 EROSION

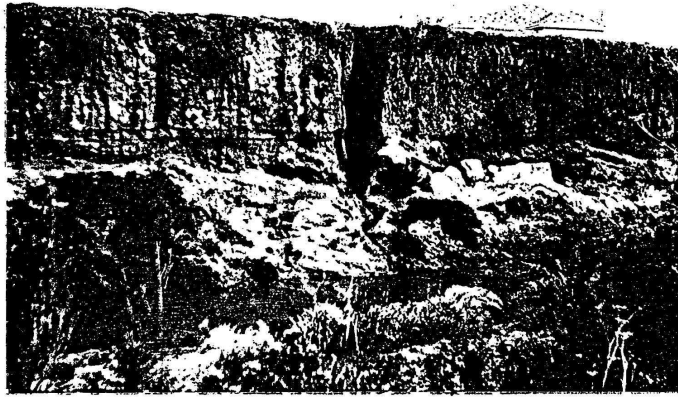
PLATE 5-1 Bank erosion near The Boulevard, Pascoe Vale, 1952  
Note gully cut into bank by surface runoff

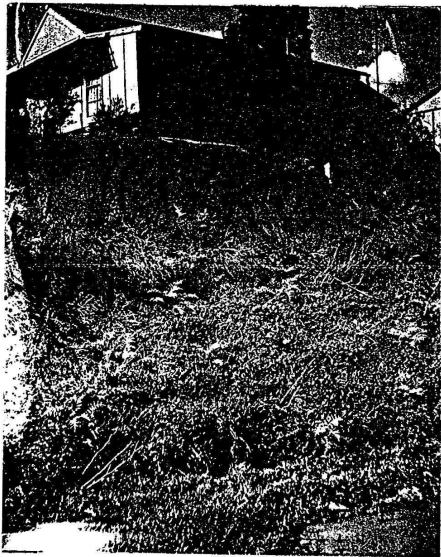
PLATE 5-2 Partly rehabilitated bank at the rear of Kernan Avenue, Pascoe Vale, 1955

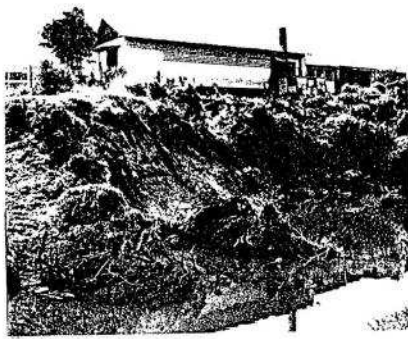
PLATE 5-3 Bank erosion and improvement works at Hilda Street, Essendon

- (a) Improvements at Hilda Street, Essendon. Complaints about erosion along Moonee Ponds Creek in the vicinity of Hilda Street, Essendon (Figs 5-3 and 5-5) date from early 1947. In June 1956, the City Engineer of Essendon reported to the Board of Works that the banks at Hilda Street were being severely eroded and commented that the erosion was being aggravated by debris in the creek which raised the water level and diverted the flow. The City Engineer requested that the Board of Works should immediately inspect the area with a view to implementing remedial measures. The severity of the erosion and the precarious position of the houses at the eastern end of Hilda Street is clearly shown in Photographs A and B in Plate 5-3.

A Bank erosion, 1954

The Sewerage Committee of the Board of Works gave approval for the construction of improvement works along this section of the creek in December 1958. Work commenced on the project in August 1959 and was completed by mid 1960. The creek was realigned, moving it away from the houses that were endangered on Hilda Street (Plate 5-4). The new channel was constructed with a 20 ft-wide concrete invert, and the toes of the banks were lined with bluestone pitchers (Fig 5-6). The channel banks were shaped to a slope of  $1\frac{1}{2}$  to 1, filling being added where necessary. The appearance of the section in August 1960, immediately after construction, is shown in Plate 5-3C and D, while Plate 5-3E and F shows the channel in 1980.

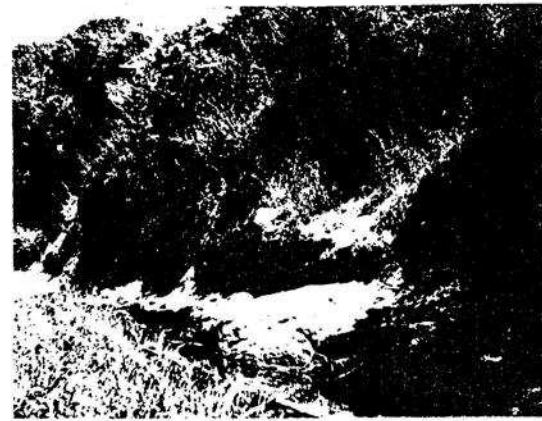
(b) Improvements at Pattison Street, Essendon. There were a number of complaints during the 1950s about bank erosion to the south of Dean Street Bridge, Essendon. As at Hilda Street, property owners were naturally concerned that their allotments were being eroded, and there was also concern that the eroded banks constituted a hazard to children. In 1957, the City Engineer of Essendon drew the attention of the Board of Works to erosion that was taking place at the rear of a number of allotments on Pattison Street (Fig 5-7A; Plate 5-5A). Approval for remedial works was given by the Board's Sewerage Committee in December 1958 (at the same time as the Hilda Street works were approved), and construction commenced in

A Erosion at the rear of No 14 Pattison Street, November 1955

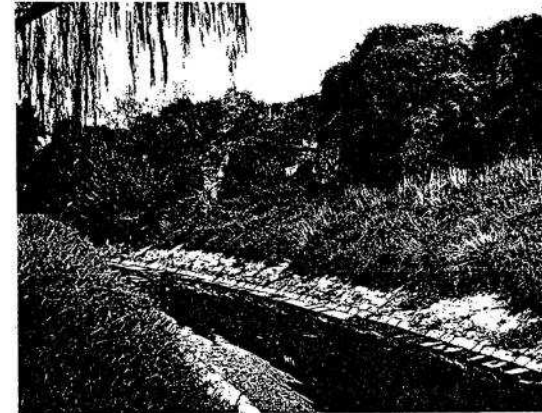
B The lined channel, 1966

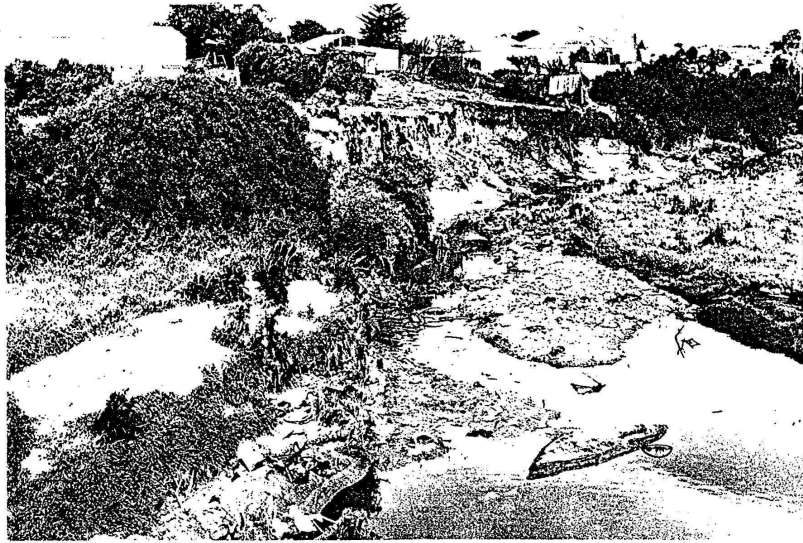
A Bank erosion at the rear of Nos 97 and 103 Waxman Parade in 1954. View looking downstream

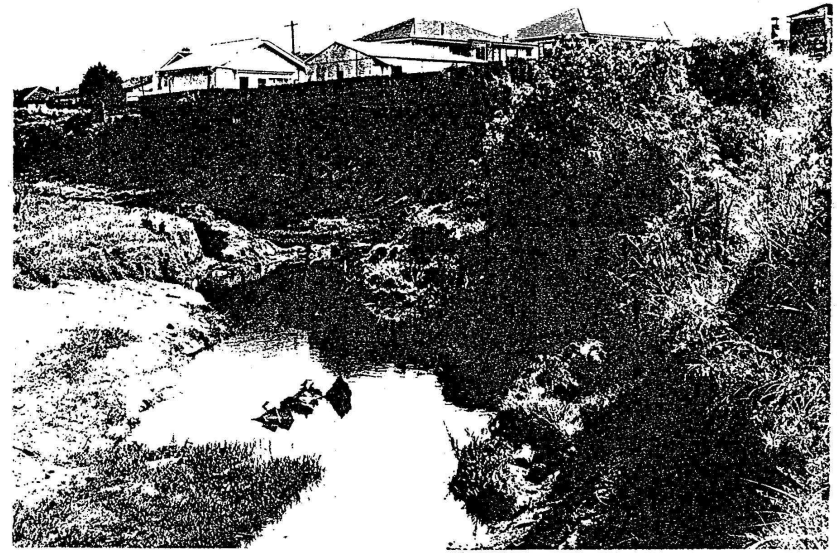
B Bank erosion at the end of Salisbury Street in 1954. View looking downstream

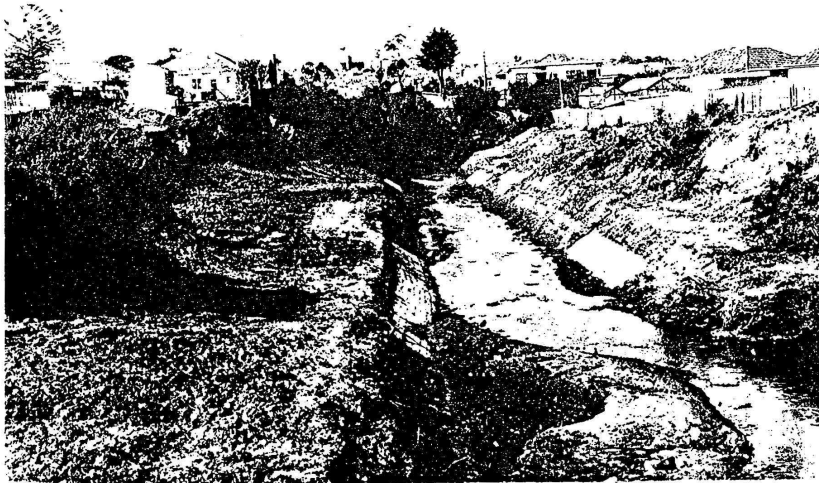
C The improved channel immediately after completion in 1960. View looking downstream

In late 1959, the Board's Engineer-in-Chief recommended that minor remedial work be carried out along a short section of the creek immediately upstream of Waxman Parade. Work commenced on the project in mid 1960. The creek was straightened and the old course filled (Fig 5-10A; Plate 5-8A and B). The banks at the ends of the new section were pitched and the invert at these points concrete lined.

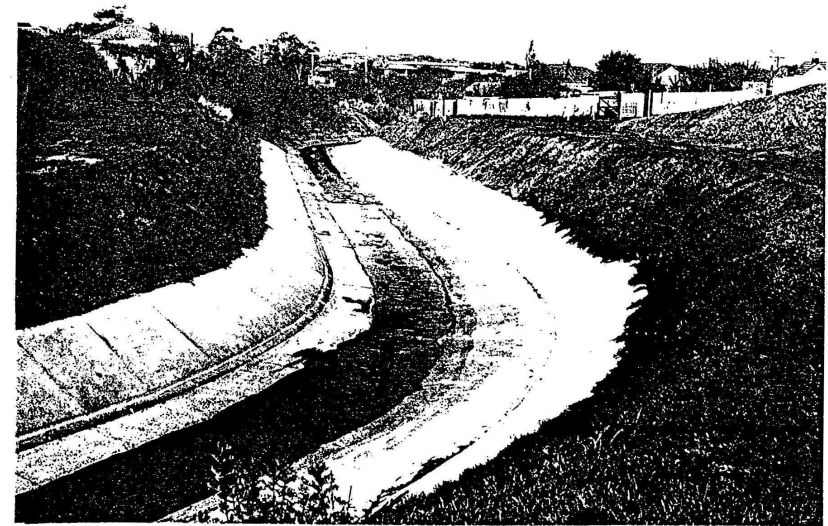
D The same reach as in C in 1975

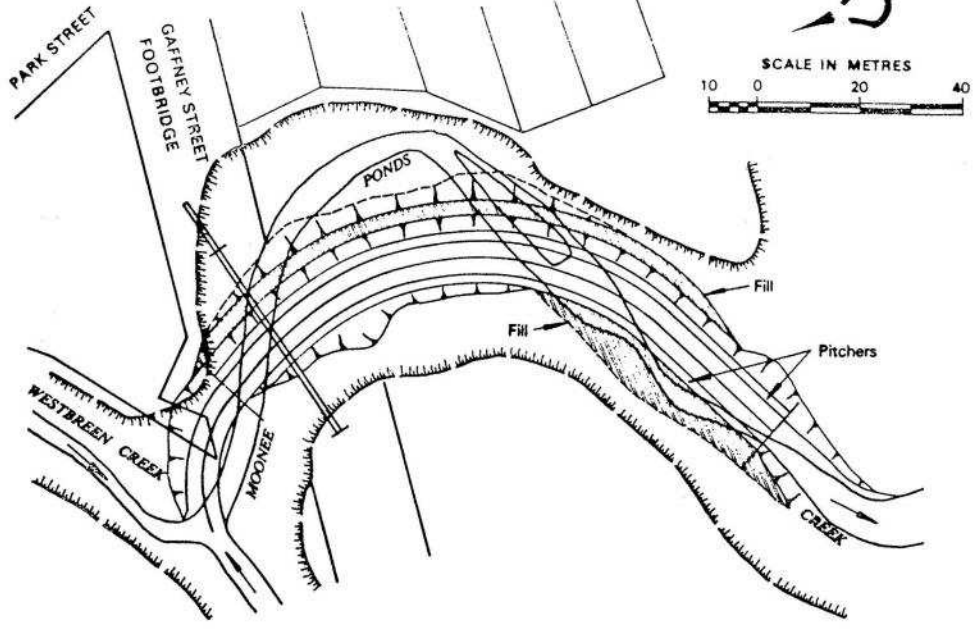
PLATE 5-6 Bank erosion and improvement works at Somerset Street, Ccburg. Views looking downstream from Gaffney Street Footbridge

A Bank erosion, 1955

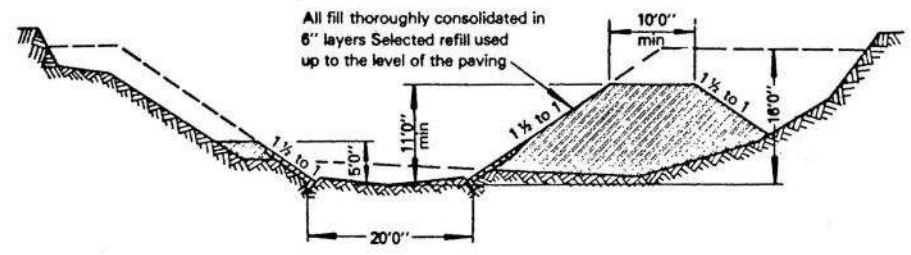
Within four years of the completion of the works, considerable quantities of silt had been deposited in the new channel and weed growth on the depositional material was prolific (Plate 5-6B). The siltation was almost certainly caused by ponding during flood flows, the watercourse downstream of the improved section being of inadequate capacity. The lined section of the creek was subsequently cleaned out and the weed growth and silt removed from the banks (Plate 5-6C). In late 1975, the section was further modified when it was incorporated into the improvement works undertaken between Gaffney Street and Margaret Street (see Section 8-4). The invert was concrete lined, the bluestone pitchers were replaced by concrete, and an access ramp was constructed (Plate 5-6D).

C The cleaned-out channel in early 1975

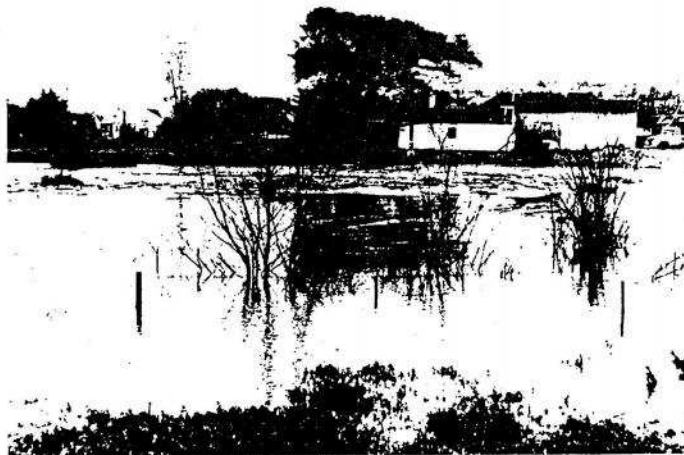
PLATE 5-14 Flooding upstream of Avoca Crescent, Coburg, 17 July, 1963

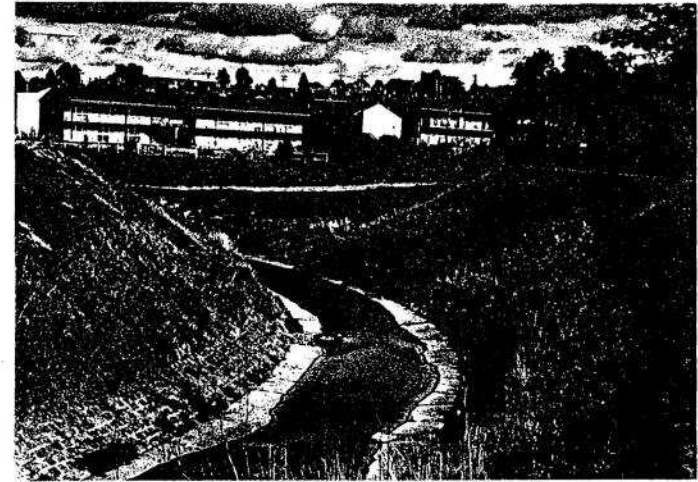
PLATE 5-15 The deviation at the junction with Five Mile Creek, mid 1980

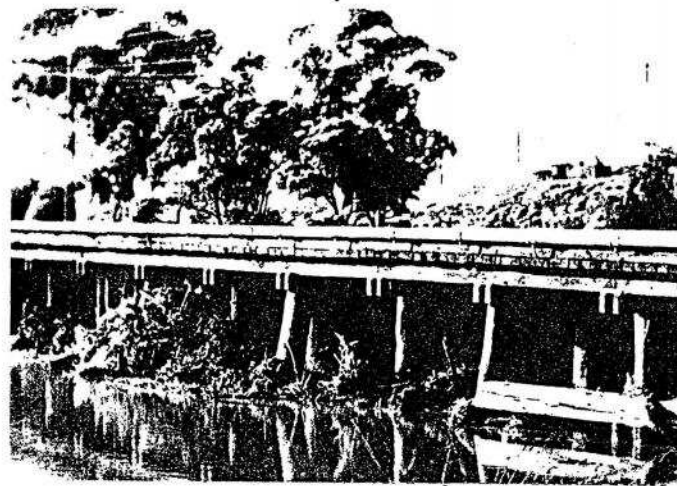
Bridge flow was restricted by accumulated debris and by the piles and whalings (Plate 5-16B, C, D), even though some of the lower whalings had been removed in 1937. At Dynon Road Bridge the passage of floodwaters was hampered by siltation of the floodways under the outer arches of the bridge (Plate 5-16F). Flooding downstream of the Gravitation Bridge can probably be attributed to the inadequate capacity of the channel between the Gravitation Bridge and Dynon Road Bridge; this section was not improved when the 5 000 cusec channel was constructed.

B Debris piled up against the Main Lines Bridge

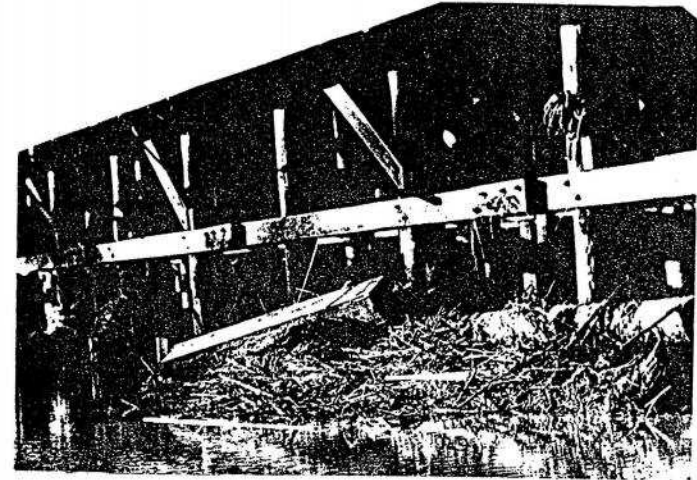
C Debris piled up against the Railways' Gravitation Bridge

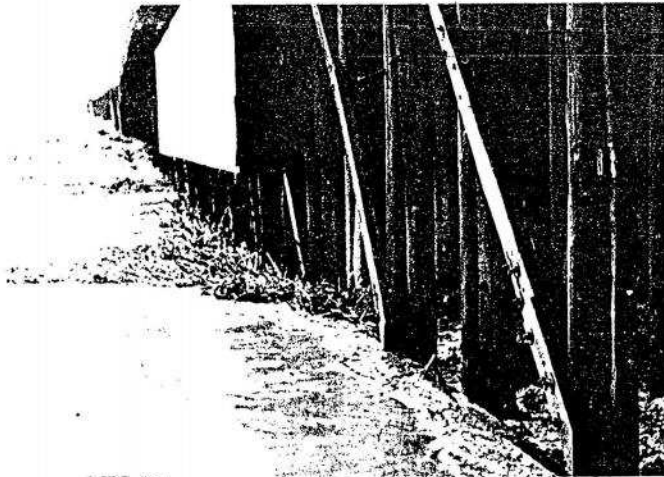
D Head-up of water on the upstream side of the Railways' Gravitation Bridge

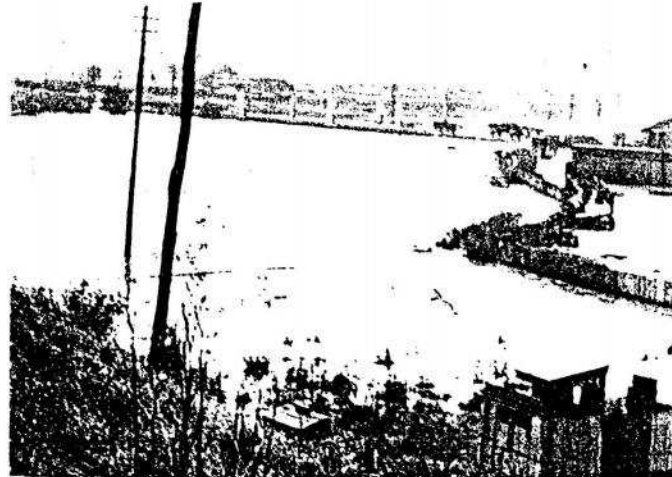
E Looking downstream towards Dynon Road Bridge

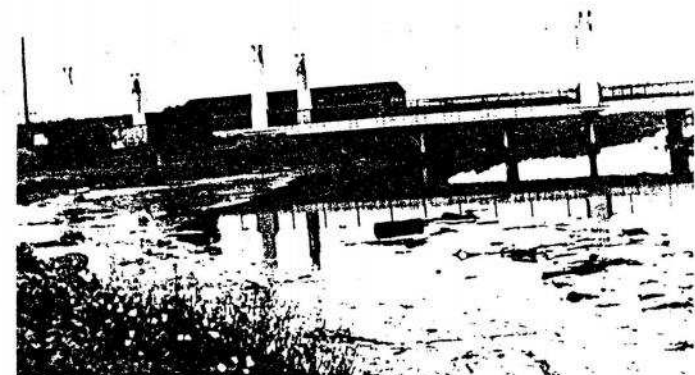
F View of Dynon Road Bridge showing the siltation under the eastern spans

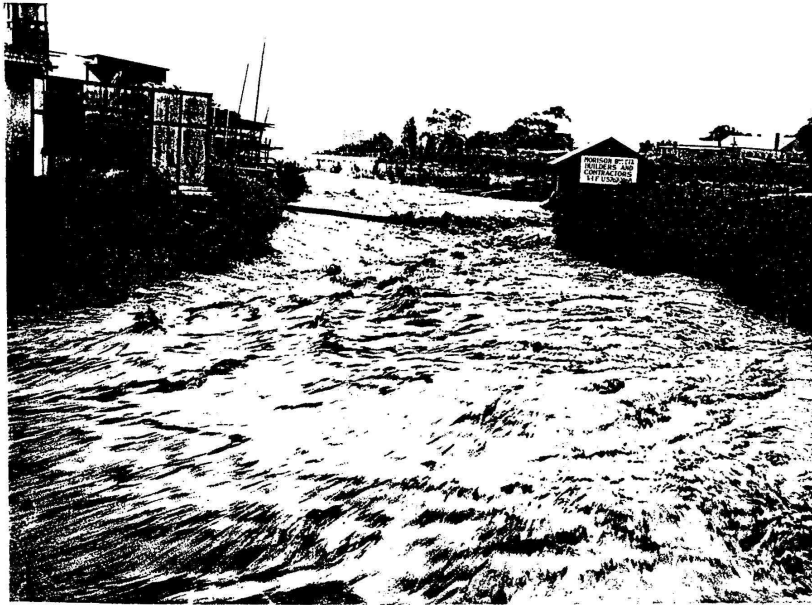
A Floodwaters racing through the constricted channel above Flemington Road Bridge

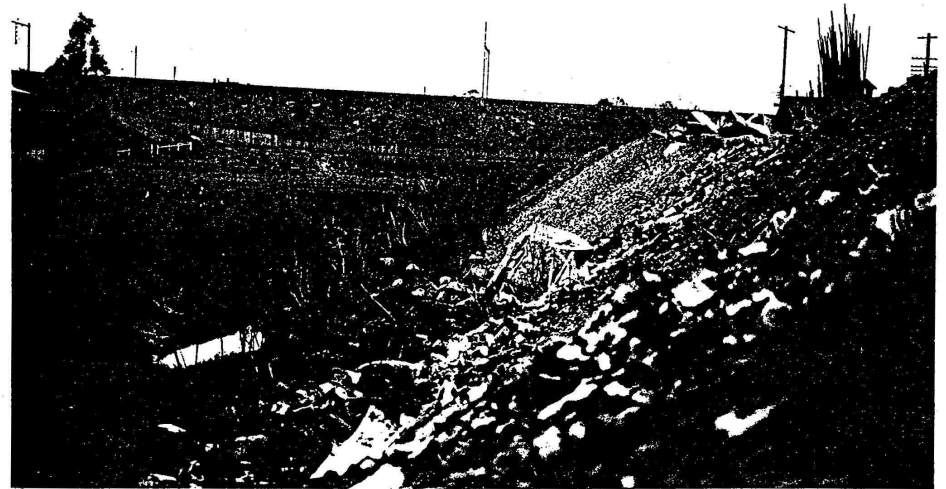
B Filling on the floodplain upstream of Flemington Road

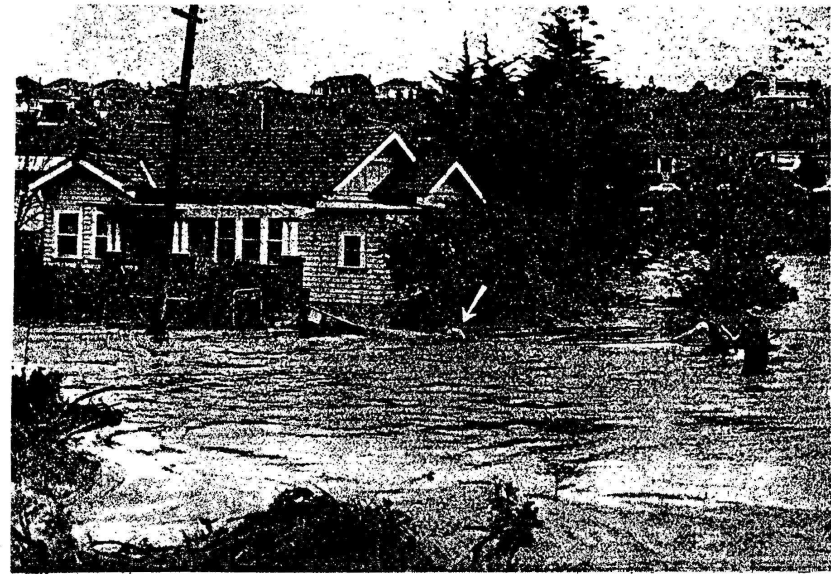
A Floodwaters at the end of Kernan Avenue, Pascoe Vale. The men were attempting to rescue two stranded sheep

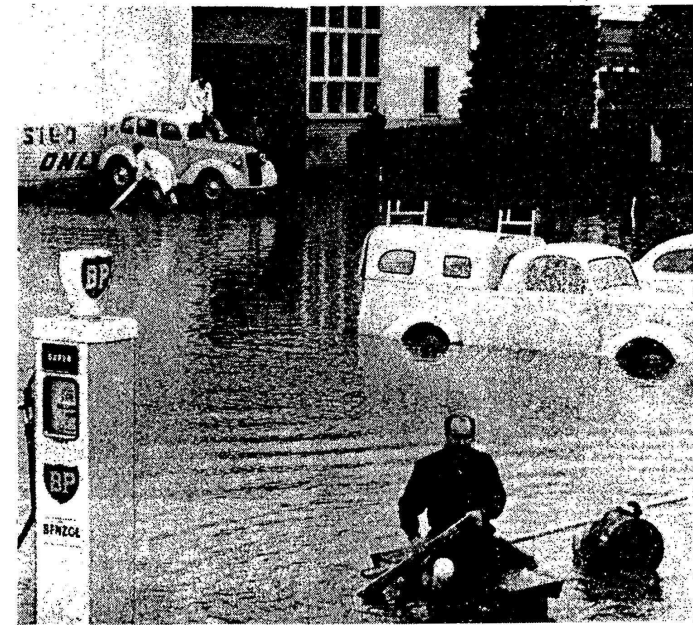
B Flooding on Mt Alexander Road

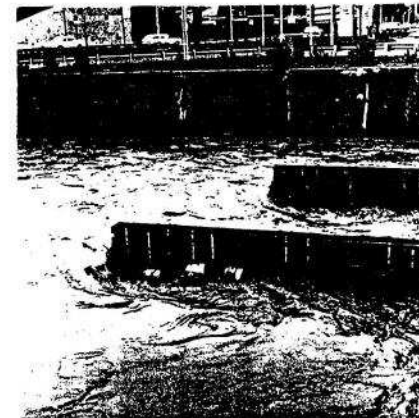
PLATE 5-20 The timber training walls on the upstream side of Flemington Road Bridge

The floods caused a very different problem along the improved section of the creek immediately upstream of Flemington Road Bridge. The new improvement works prevented extensive flooding during the 1963 floods (the flood level during the January flood was four feet lower than during the 1960 flood), but together with other floodflows eroded the edges of the lined centre channel (Plate 5-22). Frequent flushing flows of relatively high velocity had prevented grass from growing on the berms, with the result that they were progressively eroded. In addition, erosion also occurred at the entry to the new channel where the sudden drawdown of flood flows resulted in considerable turbulence. It was recommended that as it appeared unlikely that grass could be permanently established on the berms, it would be advisable to concrete-line them at an estimated cost of £20 000. It was subsequently noted, however, that a similar problem had occurred on Elster Creek, and that there the eroded sections had been filled with rock over which silt had been deposited and a grass cover established. It was decided to treat the eroded section immediately upstream of Flemington Road in a similar manner. The work was completed in 1964 at a cost of £2 000.

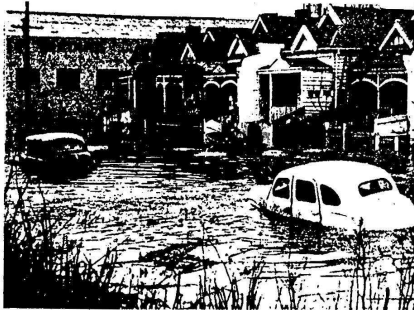
A further problem was encountered during the July flood. At the height of the storm the No 2 pump at the Macaulay Pumping Station failed, and according to a local newspaper report (Ref 6) it took the SEC four and a half hours to repair the fault. As a result of the failure, water banked up in Bent, Hardiman and Chelmsford Streets flooding a number

PLATE 5-21 Flooding at Bent Street, Kensington, July 1963  
"Source: *The Age* of 15 July 1963"

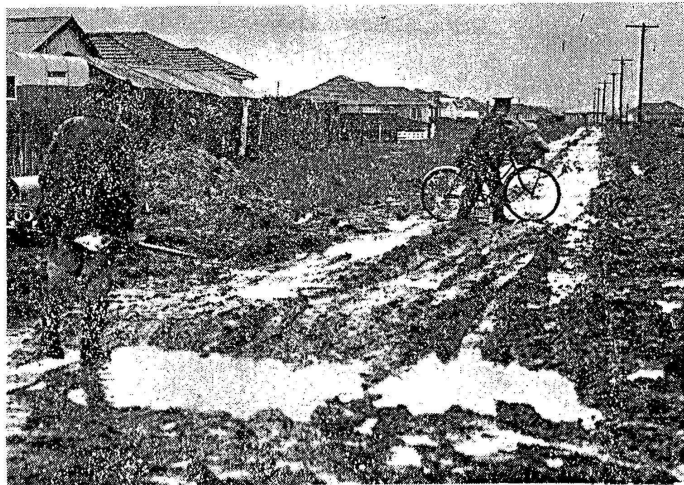
PLATE 5-23 An unmade road: James Street, Fawkner  
"Source: The Herald of 17 September 1960"
