## 4 DRAINAGE PROBLEMS AND REMEDIAL MEASURES 1892 - 1940

### 4.2 FLOODING

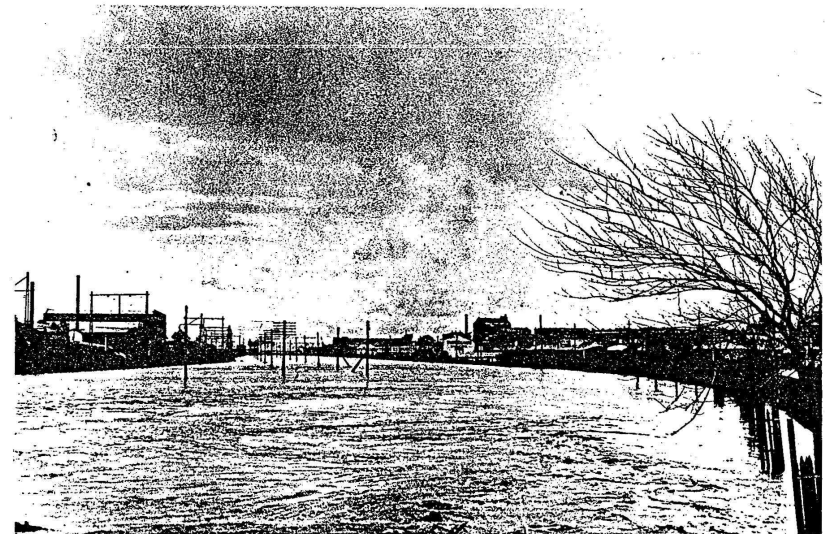
B View looking downstream from Racecourse Road Bridge

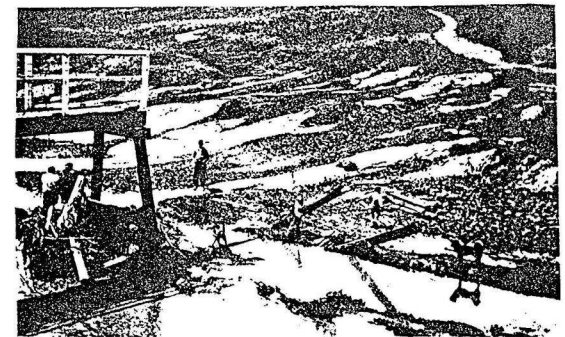
PLATE 4-2 The Christmas Day Flood, 1933

A Albemarle Street, Kensington, Boxing Day 1933

B Stubbs Street, Kensington, Boxing Day 1933

C The remains of the Hope Street footbridge

At the height of the flood some 190 houses and 45 factories in the lower part of the basin were inundated (Plate 4-2) and several hundred people had to be evacuated. Apparently many of the occupants paid little attention to the localised flooding that accompanied the torrential rain because flooding of this nature recurred frequently, but:

Damage in the area was estimated to be in the order of £ 30 000. Further upstream, the floodwaters undoubtedly eroded the vertically-sided banks along some reaches, and at Hope Street, Brunswick, a footbridge was washed away (Plate 4-2 C).

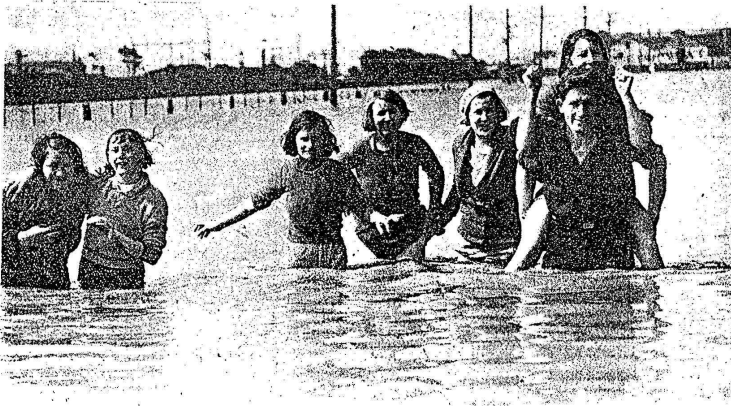
PLATE 4-3 The Flood of late November, 1934

A Aerial view of embanked channel and inundated area between Racecourse and Macaulay Roads, early December, 1934

B Stubbs Street, Kensington, 1 December 1934  
"Courtesy: Herald and Weekly Times Ltd."

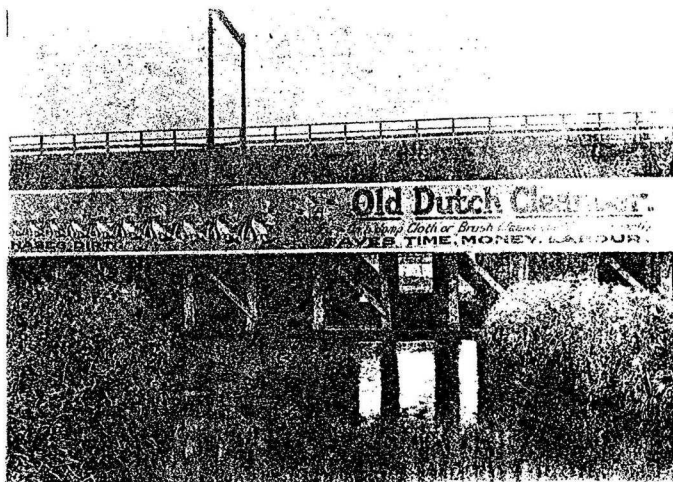
Plate 4-5 The Railway Gravitation Bridge

A—View looking downstream towards the bridge.  
Note the dense growth of vegetation along the sides of the channel.

B—Heading up of floodwaters — Boxing Day, 1933

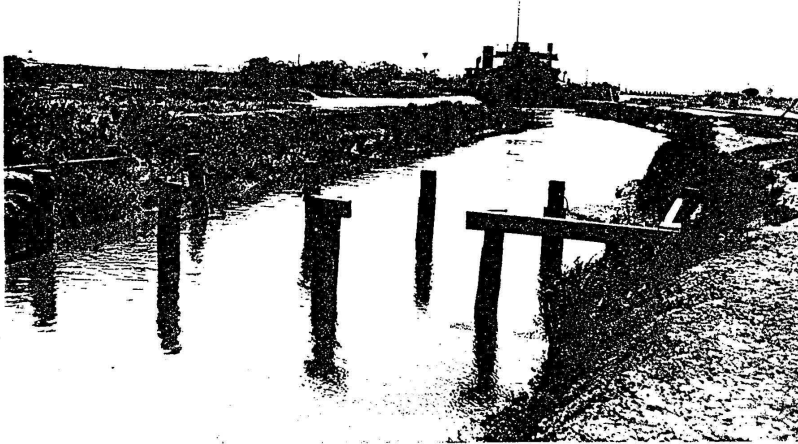
PLATE 4-7 The constructed outlet of Moonee Ponds Creek partially blocked by the dredge "Lady Stanley" 12 January 1934. The piles in the foreground are all that remains of one of the temporary bridges that were washed away during the Christmas Day flood of 1933

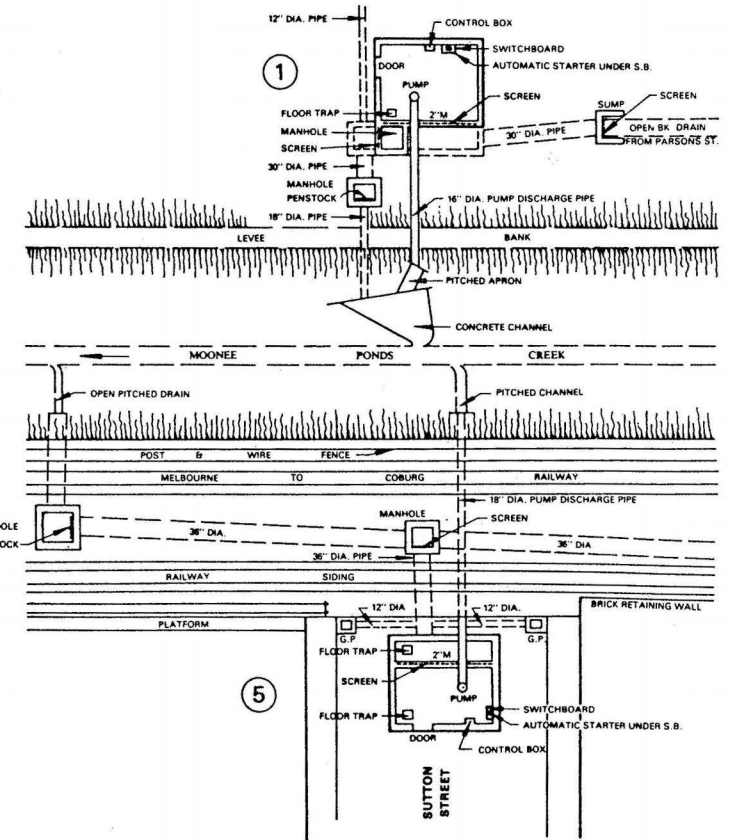
Figure 4-9

THE MELBOURNE CITY COUNCIL'S PUMPING STATIONS

In 1938, as an integral part of the 5 000 cusec channel project, the Melbourne City Council installed five pumping stations to remove storm runoff from the low-lying areas behind the levee banks. The location and layout of the five stations is shown in Figure 4-9, and the areas drained by each station and the times required for the pumps to clear a 10-year flood are given in Table 4-4. The penstocks were manually closed when the creek began to rise, while the rising water in the street drains behind the penstocks automatically activated the pumps by means of float switches.

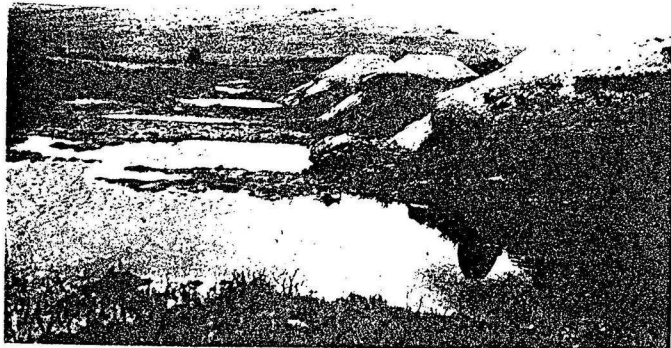
PLATE 4-9 Sand removal from Moonee Ponds Creek during the 1930s

A Sand removed from the creek bed: locality unknown

B Screening sand near the Railway Trestle Bridge Broadmeadows

C Sand being removed near Bent Street, Moonee Ponds. The old Wilson Street Bridge can be seen in the background

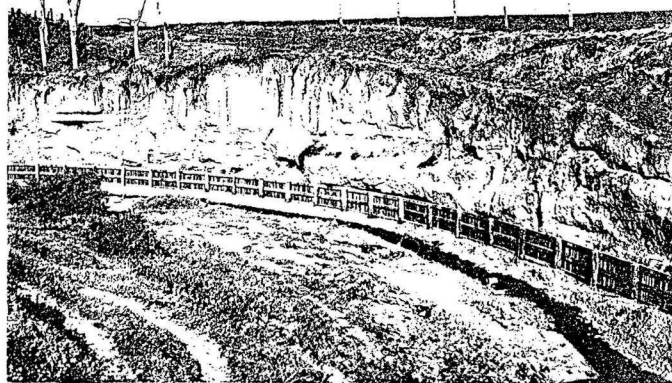
PLATE 4-12 Eroded bank and retaining fence built by the MMBW Reynard Street, Pascoe Vale 1934

Although sand mining activities had pronounced effects locally, the expansion of the built-up area and the resultant increase in volumes and rates of runoff was probably a more important factor contributing to serious and extensive erosion observed along the middle reaches of Moonee Ponds Creek. One contemporary report noted that at a number of points between Primrose Street and the eastern end of Vanberg Road in Essendon the creek had shifted more than thirty feet in the previous fifty years. On a number of allotments adjoining the creek fences were undermined and washed away, strips of land were washed into the creek, and houses were threatened (Plates 4-10 and 4-11). At some sites wooden retaining walls were built in an attempt to arrest the erosion (Plate 4-12).

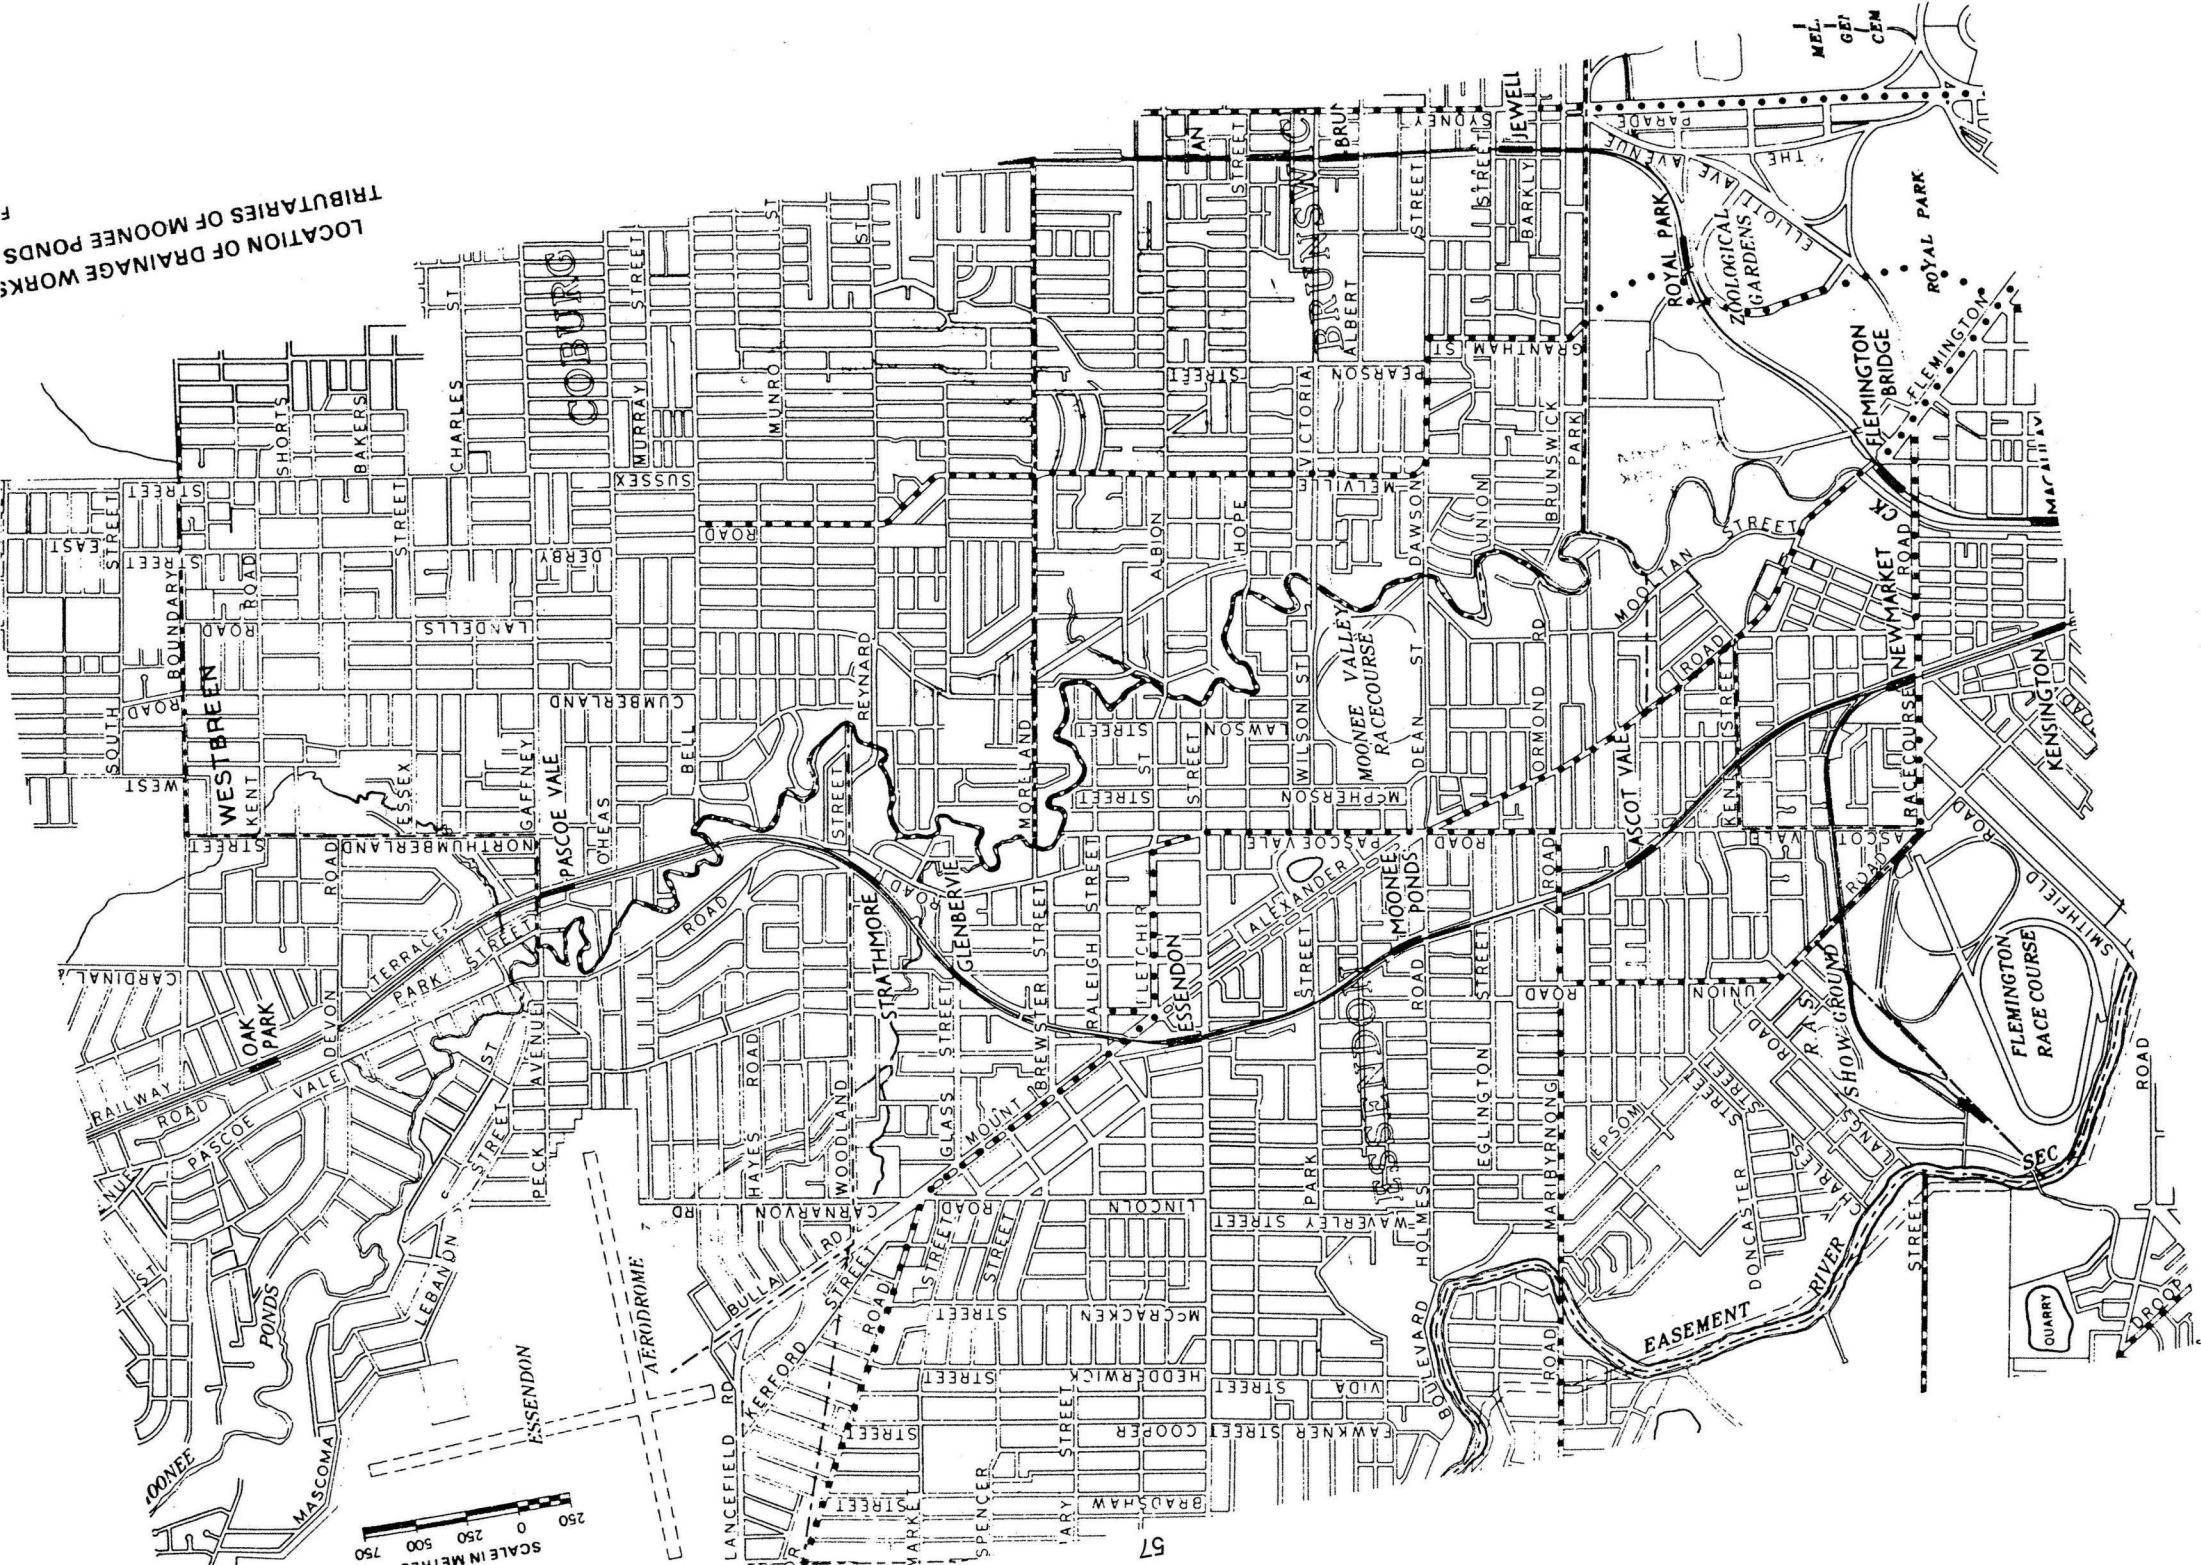
LOCATION OF DRAINAGE WORKS  
TRIBUTARIES OF MOONEE PONDS

As the urban area expanded within the lower and middle parts of the basin during the latter part of the nineteenth century and the early decades of the present century (Fig 1-5), the local councils undertook improvement works along some of the tributary watercourses. The Melbourne City Council undergrounded the Arden Street drain from the Moonee Ponds Channel to just east of Bridge Street as early as 1887 (Fig 4-12) and duplicated this drain along the southern side of Arden Street in 1907. Most of the early works, however, involved the construction of pitched channels to improve the sanitary state of the creeks and to reduce erosion. Increased runoff from the suburban areas had accelerated erosion along a number of watercourses. Leach (Ref 16), writing in 1907,

Under the Metropolitan Rivers and Drainage Act 1923, the Board assumed responsibility for creek maintenance along the tributaries of Moonee Ponds Creek, replacing the local councils. Between 1926 and 1940, the Board of Works carried out improvement works along some of the tributary watercourses; some sections were cleaned out, some were lined with pitchers (Plate 4-15), while underground drains were constructed along others. Underground drains were installed as a permanent solution to the erosion problem and for sanitary reasons. They were constructed along sections of the Royal Park, Melville, Hope Street, Albion Road, Coonans Road, and Five Mile Creek Main Drains (Fig 4-12). Detailed locality plans and details of the various drain designs are given in Appendix A. Of particular interest are the horseshoe drains that were constructed along parts of the Royal Park and Melville Drains (Plate 4-16). The shape of this type of drain was ideally suited to the morphology of the deeply incised Melville Creek. Of historical interest is the fact that parts of the Melville Drain were constructed by the pneumatic core process, whereby the formwork consisted of a long inflated rubber tube which supported the concrete until it set (Plate 4-17). This process, which was first used by one of the Board's contractors in 1928 on the Westley Street Drain in Hawthorn, was not a great success because the finished work tended to be irregular and mis-shapen, and its use was discontinued.

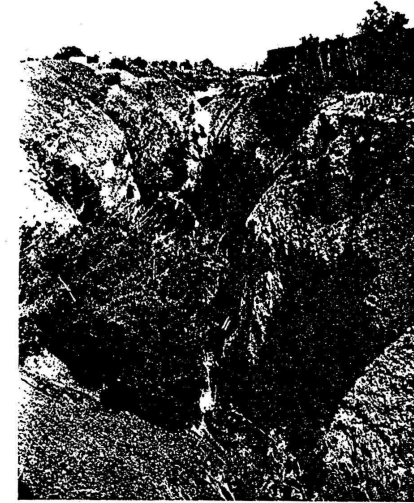
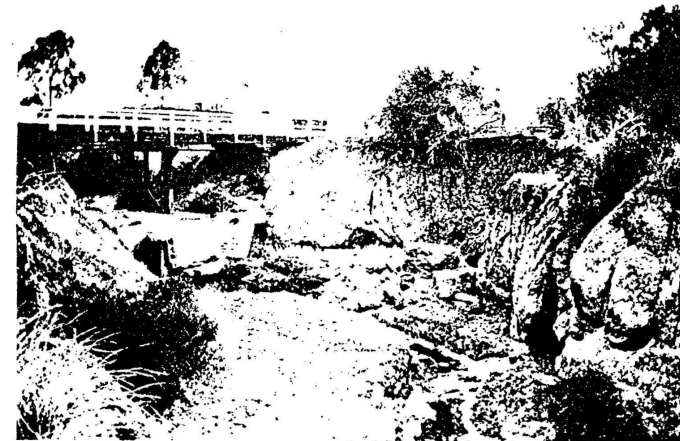
PLATE 4-14 Erosion along Melville and Coonan's Creeks in the 1930s

A Coonan's 'gully' at Moreland Road, Brunswick

B Melville Creek, Brunswick

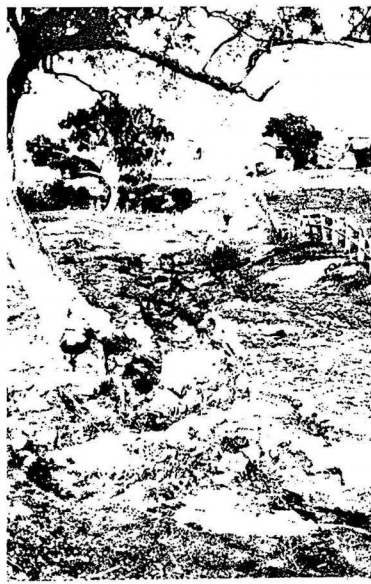
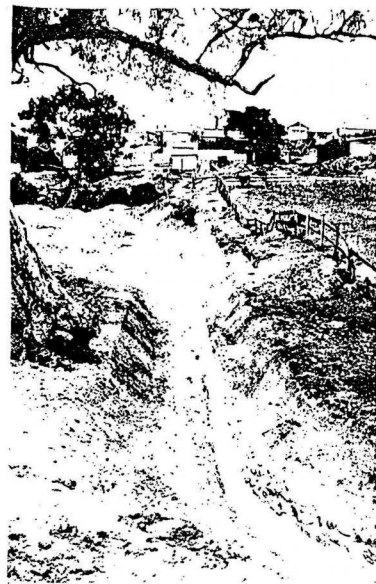
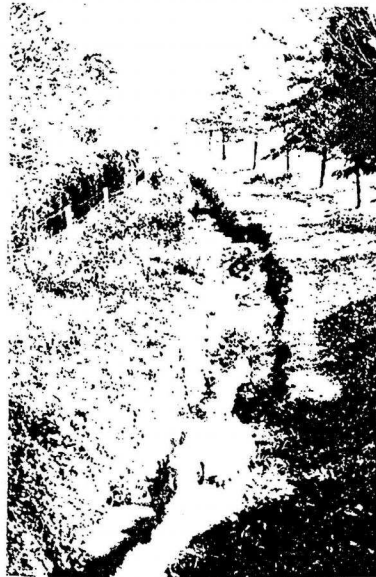
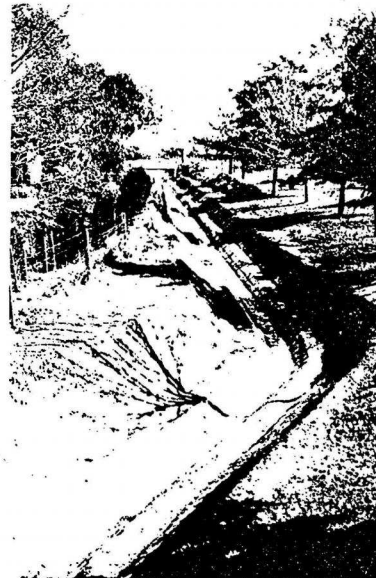
PLATE 4-15 Improvement Works along Five Mile Creek: Before and after construction

A Near Hesleden Street before construction

B Near Hesleden Street after construction

C Upstream from Napier Street before construction

D Upstream from Napier Street after construction

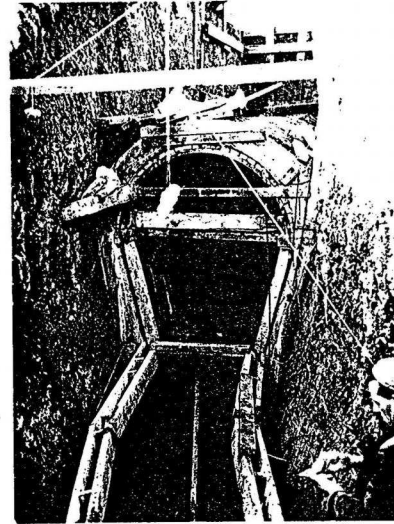
PLATE 4-16 Horseshoe drains

A Royal Park Drain: Outlet at Moonee Ponds Creek

B Melville Main Drain

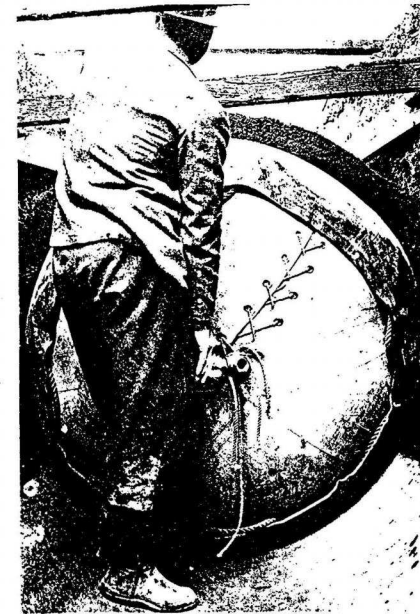
PLATE 4-17 The pneumatic core process. Locality unknown

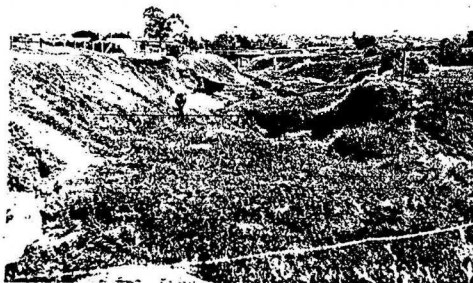
Figure 4-14

PLAN OF McLEAN STREET BRIDGE

PITCHED CHANNEL - AV. CROSS SECTION

MELVILLE CREEK AT McLEAN STREET BRIDGE
