6 RETARDING BASINS

6.2 THE JACANA RETARDING BASIN

7 THE TULLAMARINE FREEWAY : ASSOCIATED DRAINAGE WORKS

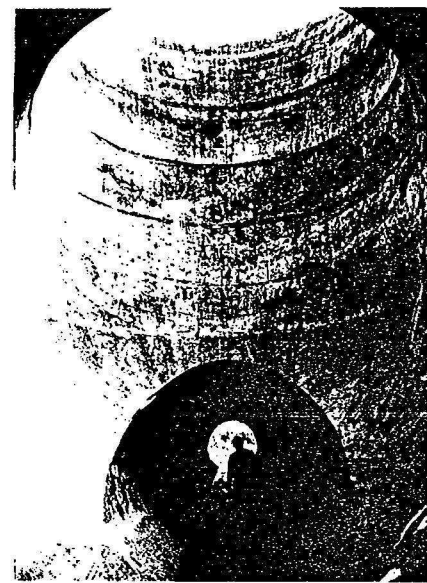
PLATE 6-4 Jacana Retarding Basin: the normal outlet pipe and the glory hole spillway

B The entry of the glory hole spillway into the normal outlet pipe

C Close-up view of the combined normal and glory hole outlet pipe

Stage storage and stage discharge curves for the basin are shown in Figure 6-1. The normal outlet pipe is 2.7 m (9 ft) in diameter (Plate 6-4A), and the discharge through the pipe at glory hole spillway level is 62.3 cumecs (2 200 cusecs). When the basin was designed it was assumed that the glory hole spillway would become operational if a 1 in 20 year or greater storm occurred, and the sidelong spillway would become operational if a 1 in 100 year or greater storm occurred. It has been estimated that discharge through the glory hole spillway at design top level (that is the level of the base of the sidelong spillway) would be 135.95 cumecs (4 800 cusecs), which combined with a flow of 65.15 cumecs (2 300 cusecs) through the normal outlet, gives a total outflow from the basin of 201.10 cumecs (7 100 cusecs). In the extremely unlikely event of water flowing over the sidelong spillway, this would be added to the discharge from the normal and glory hole outlets. As the height of water flowing over the sidelong spillway increased, discharge through the glory hole spillway would also progressively increase because of the additional head created (Table 6-2).

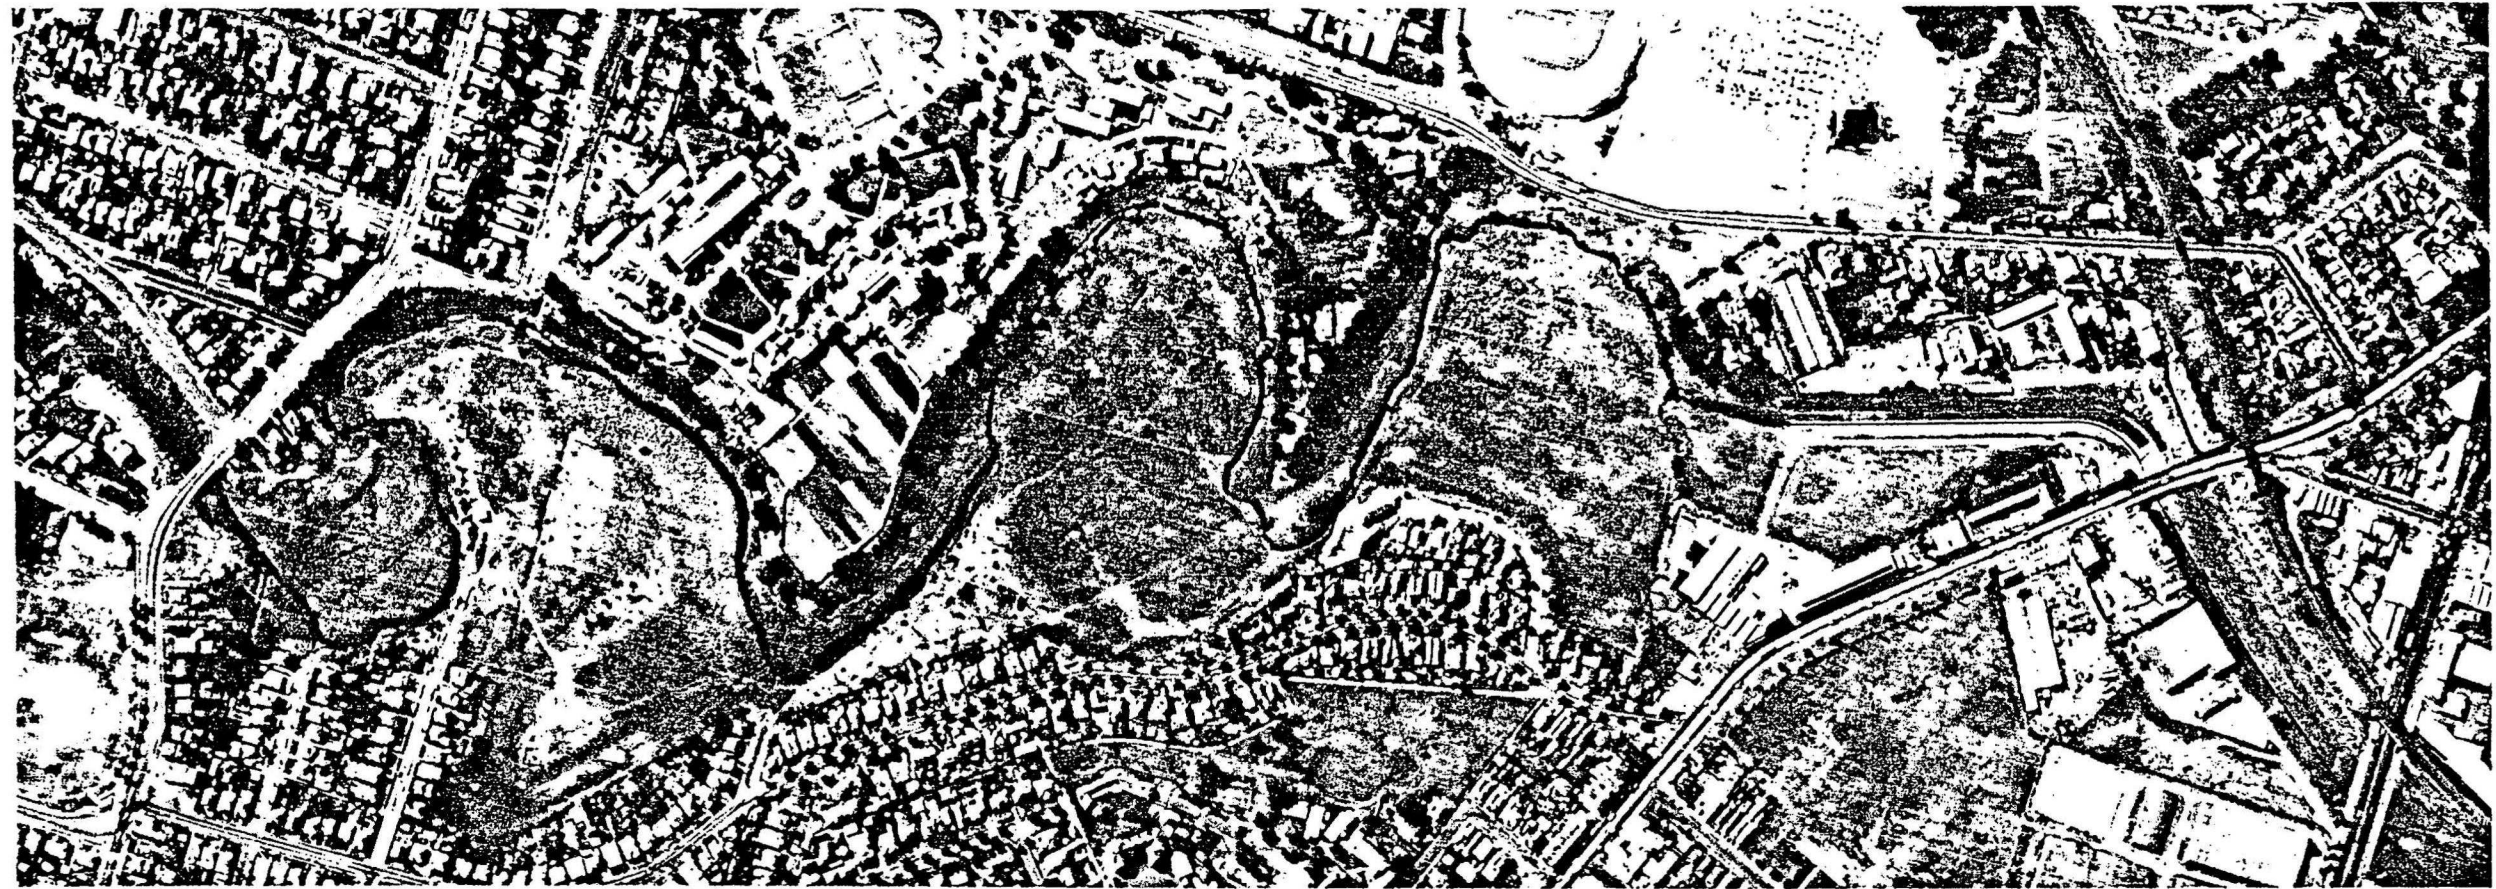
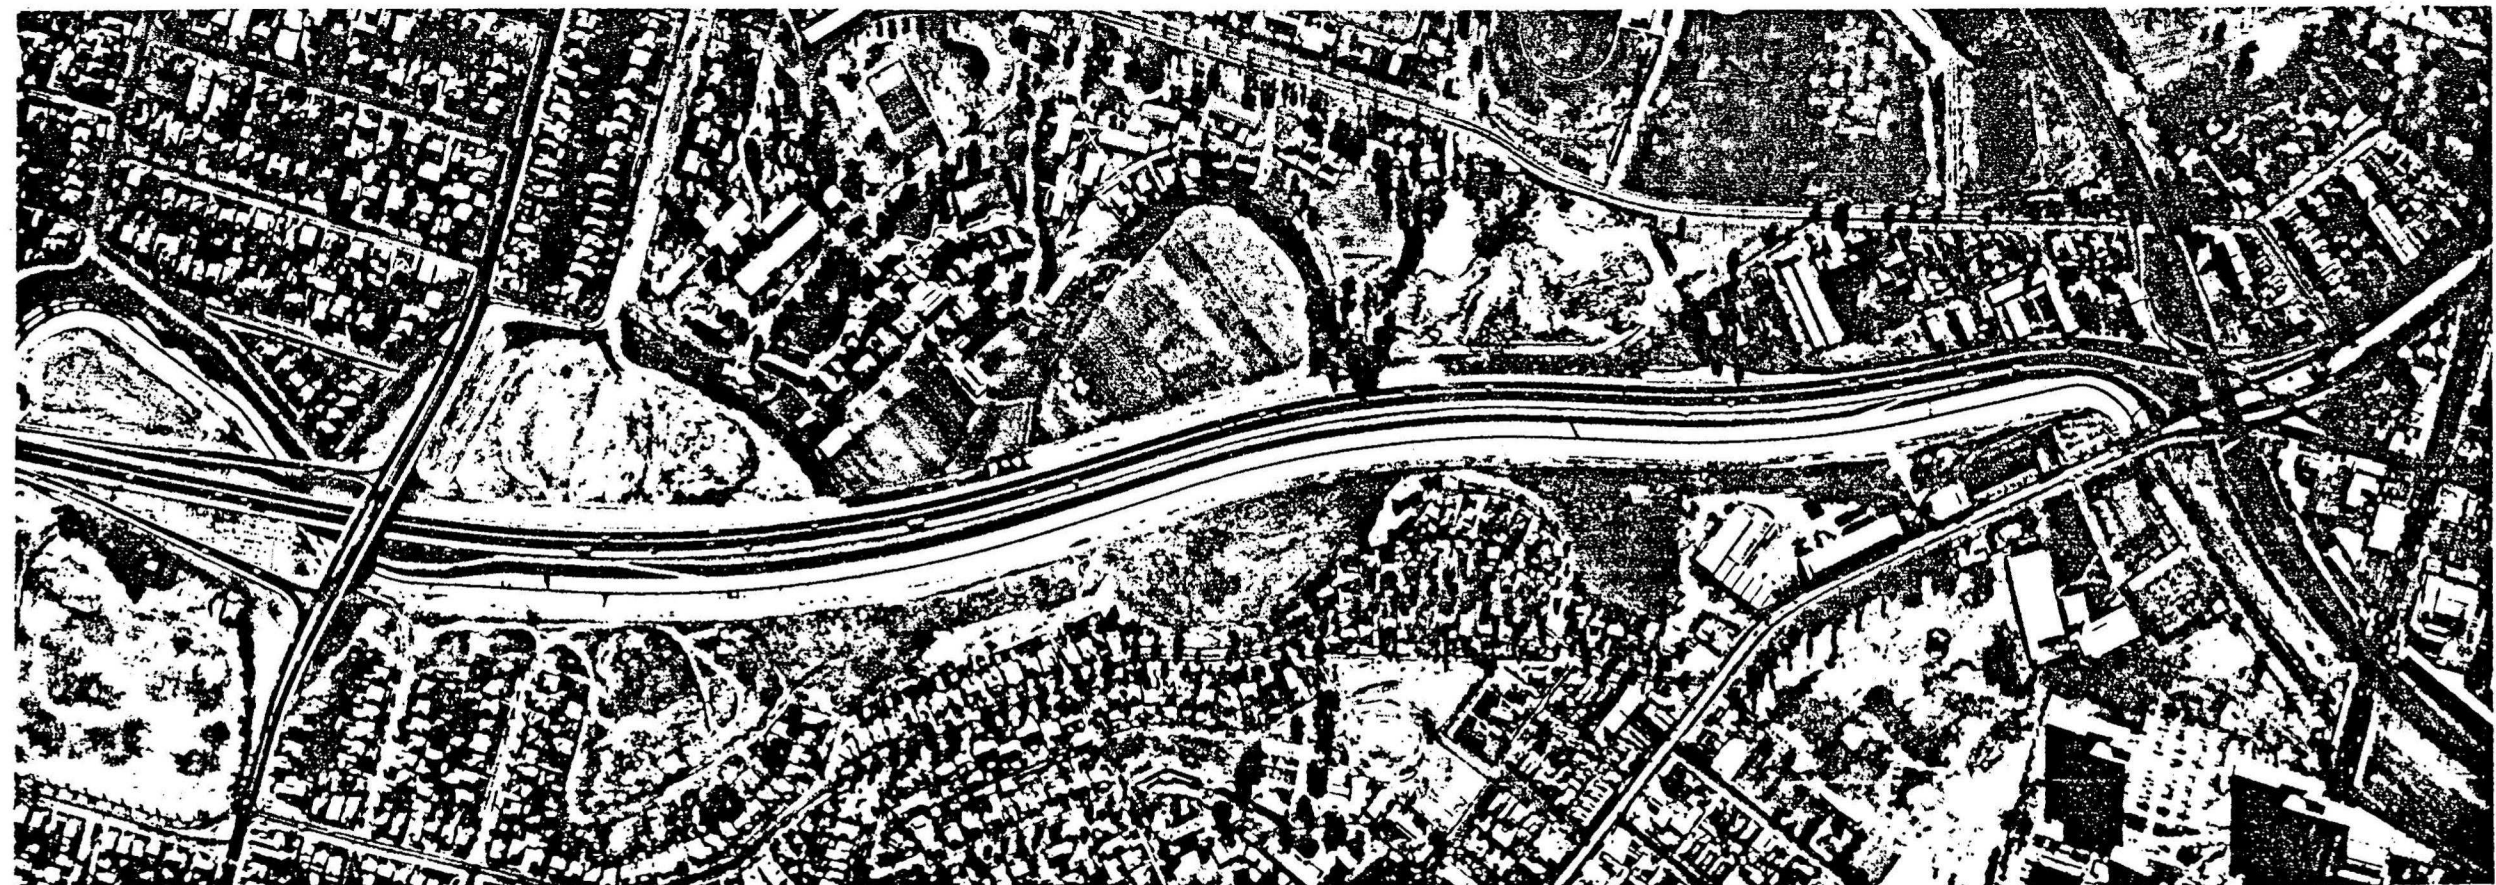
REALIGNMENT OF THE CHANNEL BETWEEN FLEMINGTON ROAD AND ORMOND ROAD

A-1966

B-1972

Between Flemington Road and Ormond Road the Freeway was constructed across the floodplain of Moonee Ponds Creek necessitating the almost complete realignment of the watercourse (Plate 7-1). Work commenced on the realignment of the creek in January 1967, and the job was completed in the December of that year at a cost of \$765 419. As reference to Plates 7-1 and 7-2 will show, a partially concrete-lined, embanked

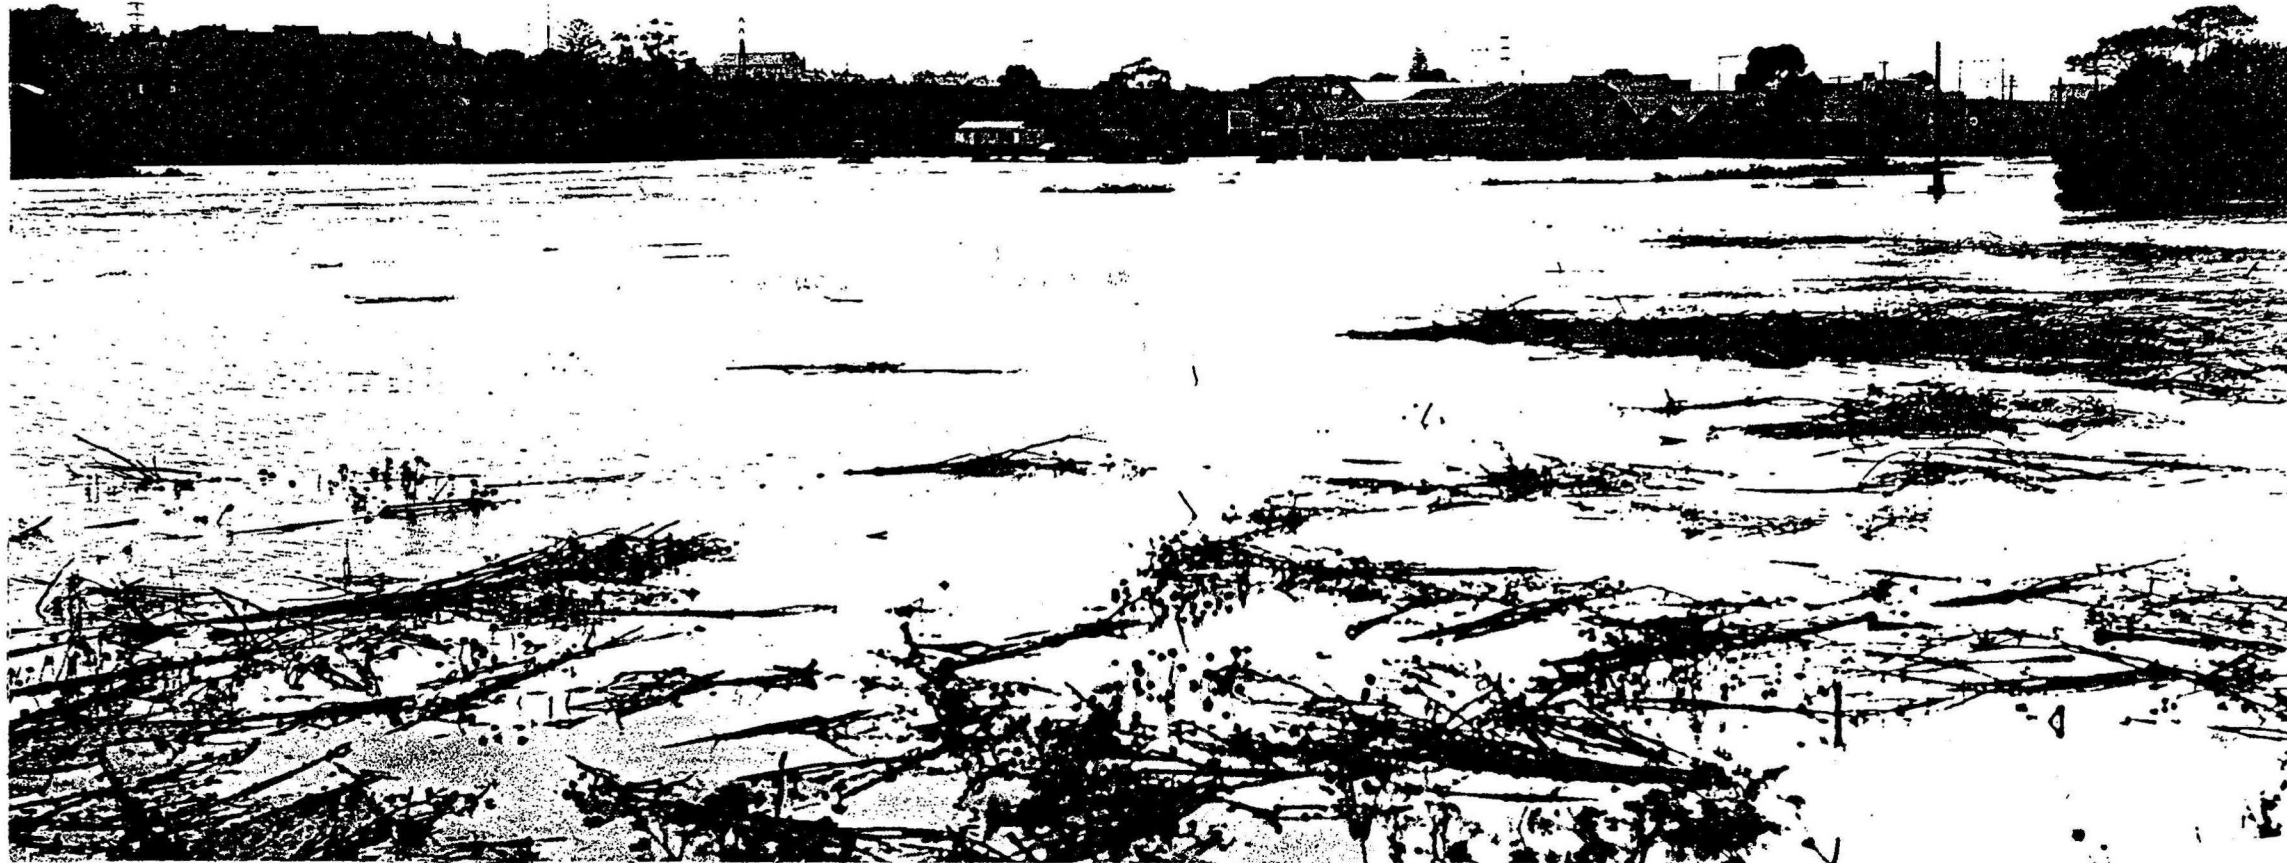
PLATE 7-3 Floodwaters ponded upstream of Flemington Road. The photograph was probably taken during the February 1946 flood

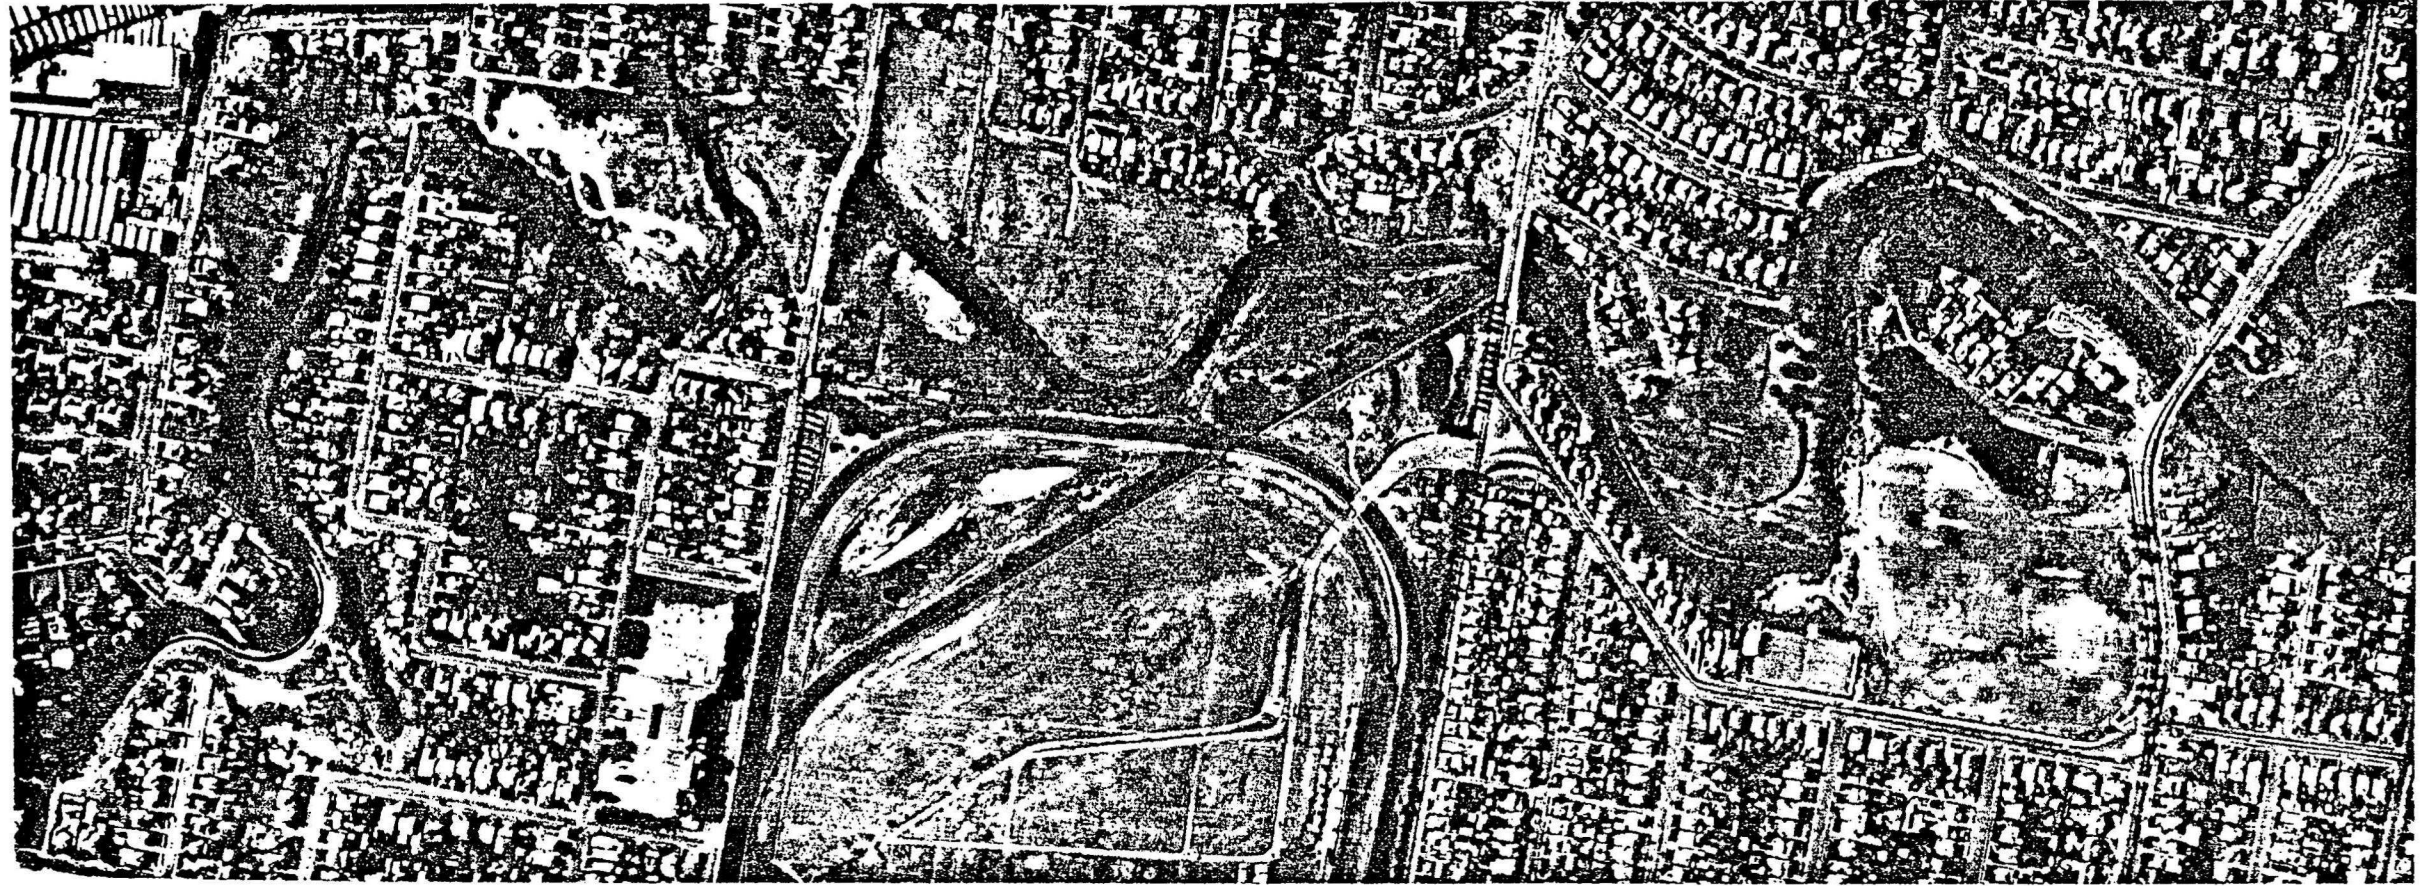
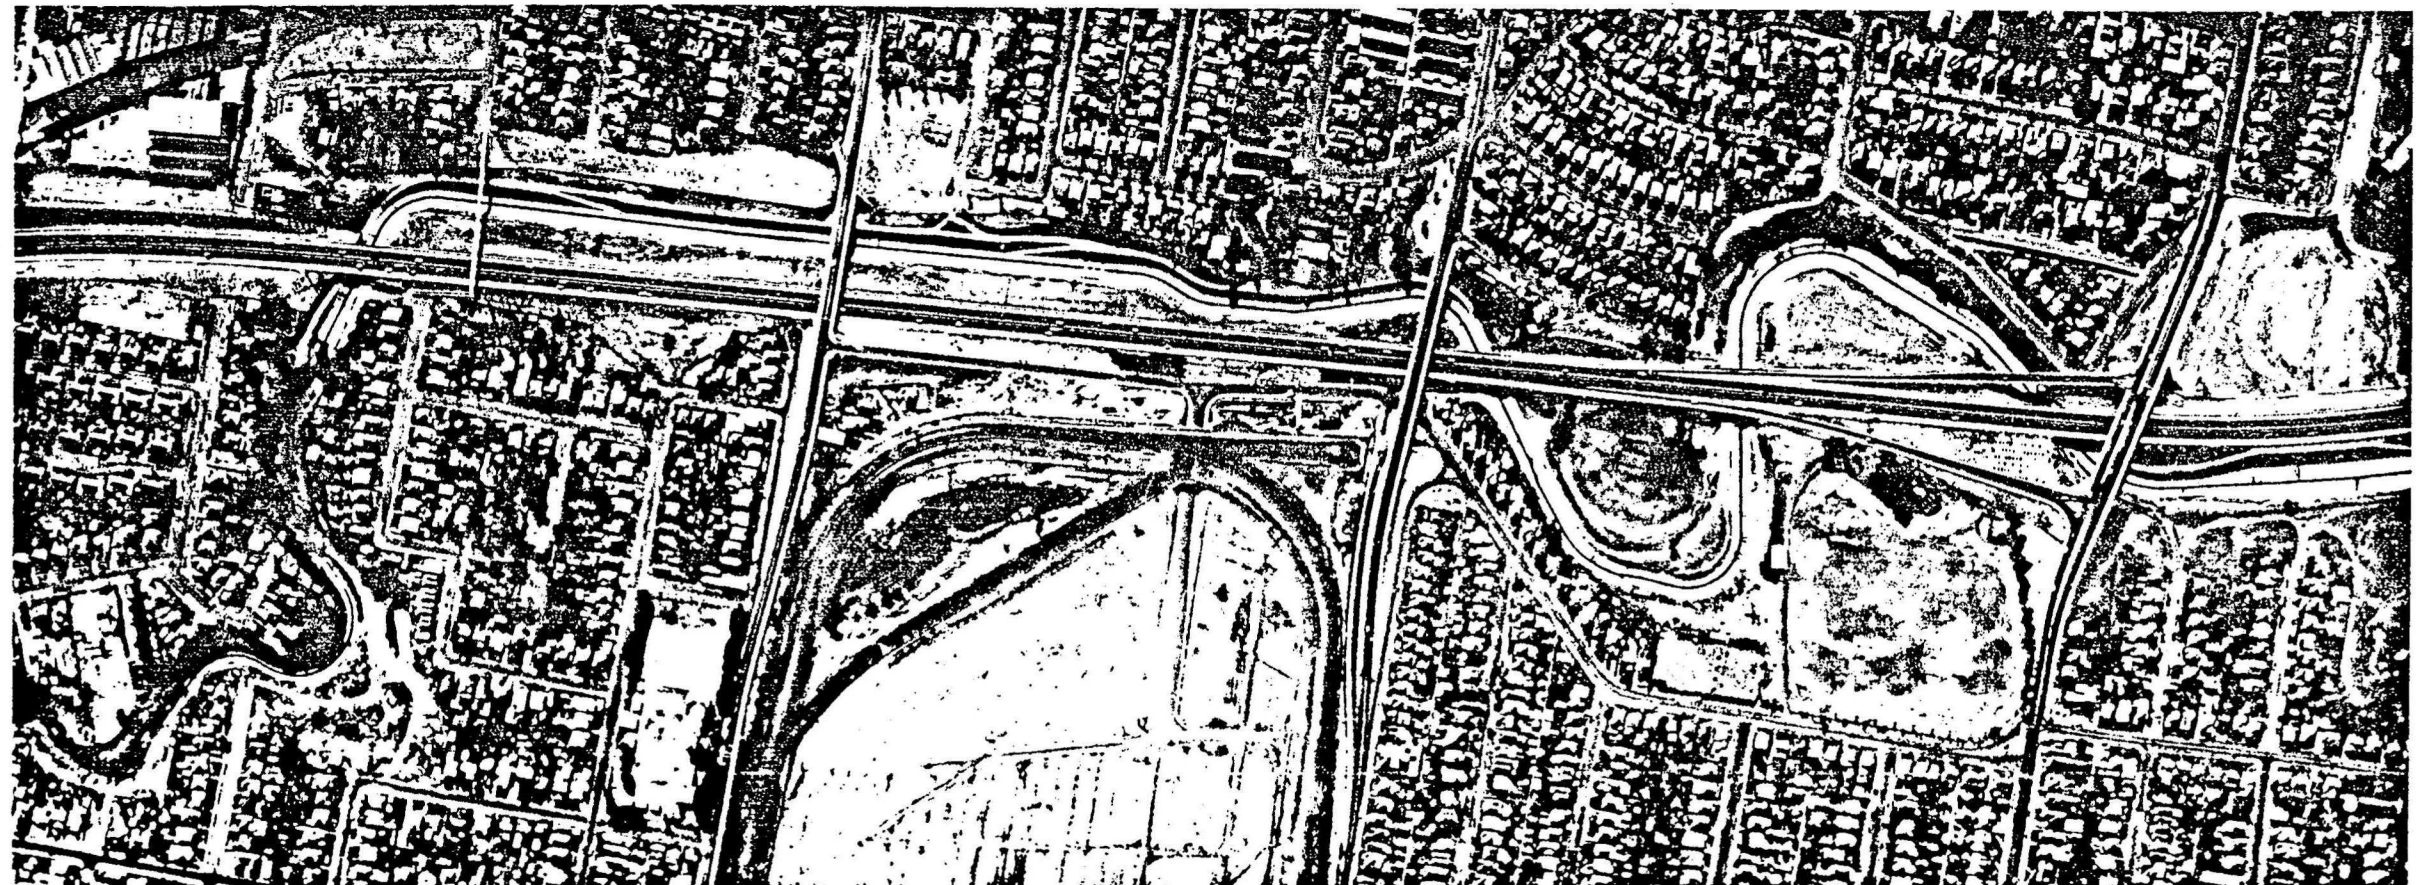
REALIGNMENT OF THE CHANNEL BETWEEN ORMOND ROAD AND EVANS STREET

A-1966

B-1972

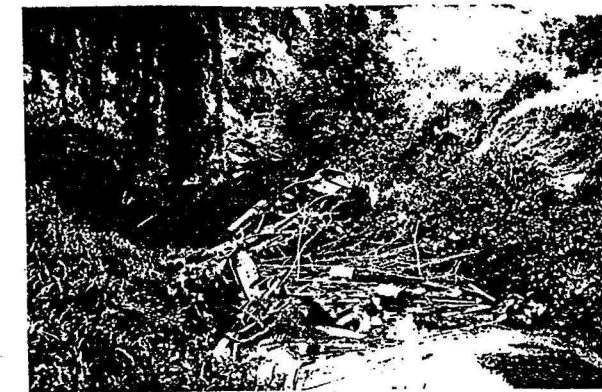
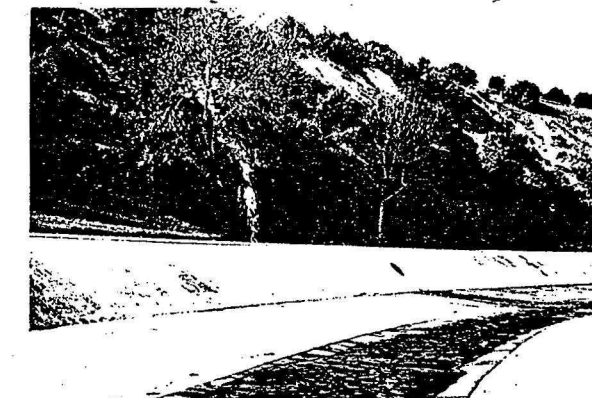
PLATE 7-6 The Silurian outcrop on the east bank of the creek upstream of Ormond Road

A The channel around the turn of the century. The area is being used as a rifle range

B The vegetation/debris-choked channel in the late 1950s

C The improved channel mid 1980

The form of the channel and of the outcrop as they appear today is shown in Plate 7-6A, and the appearance of this section of the creek in 1902 and during the late 1950s in Plate 7-6B and C. The contrast between the barren nature of the creek around the turn of the century and its vegetation/debris - choked condition before the improvement works were carried out is particularly striking.

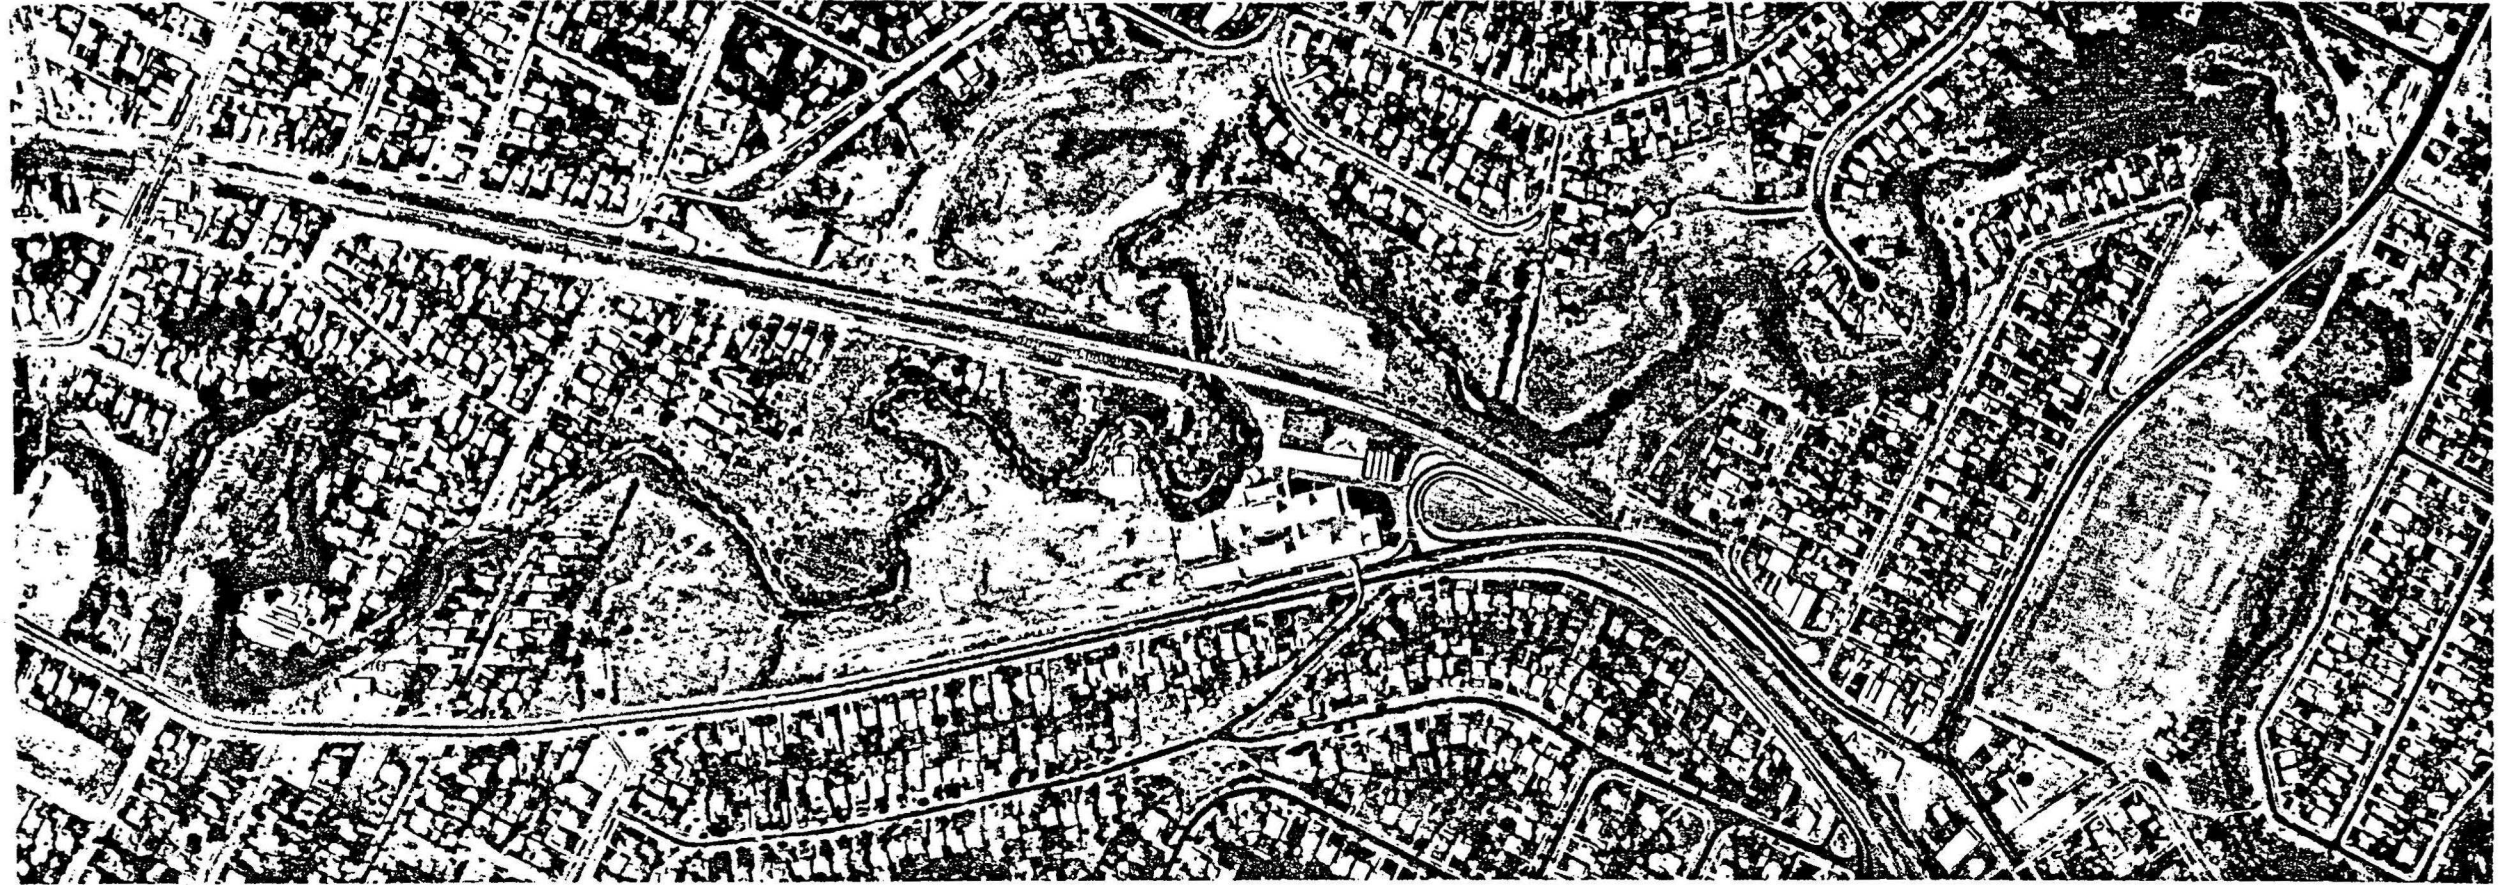
Figure 7-5

REALIGNMENT OF THE CHANNEL BETWEEN REYNARD STREET AND TATE STREET

A-1966

B-1972

TYPE SECTION

DRAINAGE WORKS REYNARD STREET TO TATE STREET

The construction of the Freeway necessitated the realignment of the creek at Bell Street to accommodate the Freeway - Bell Street intersection (Fig 7-2; Plate 7-7). The channel was partially hard-lined from the existing lined section at Avoca Crescent [See Section 5.1.3 (f)] downstream to Reynard Street. Unfortunately, it was not possible to relocate the Essendon - Broadmeadows railway bridge, and the new channel passes under the bridge in a tight 'S' bend which is hydraulically far from ideal. The channel invert is dish-shaped, and at a number of points along the channel there are energy dissipating drop structures (Fig 7-5; Plate 7-8). Discharge capacity/frequency estimates for the improved channel are given in Table 7-3.
