## 5 DRAINAGE PROBLEMS AND REMEDIAL MEASURES 1941-1967

### 5.1 EROSION

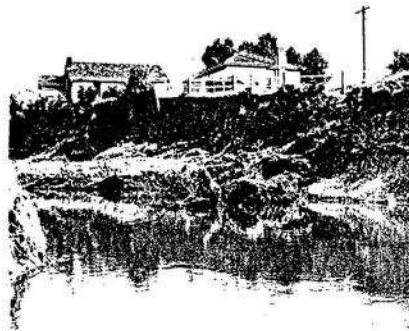
- (a) Improvements at Hilda Street, Essendon. Complaints about erosion along Moonee Ponds Creek in the vicinity of Hilda Street, Essendon (Figs 5-3 and 5-5) date from early 1947. In June 1956, the City Engineer of Essendon reported to the Board of Works that the banks at Hilda Street were being severely eroded and commented that the erosion was being aggravated by debris in the creek which raised the water level and diverted the flow. The City Engineer requested that the Board of Works should immediately inspect the area with a view to implementing remedial measures. The severity of the erosion and the precarious position of the houses at the eastern end of Hilda Street is clearly shown in Photographs A and B in Plate 5-3.

B Bank erosion, 1954

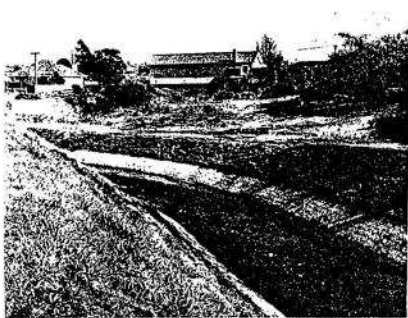
C View looking downstream in 1960 immediately after completion of improvement works

The Sewerage Committee of the Board of Works gave approval for the construction of improvement works along this section of the creek in December 1958. Work commenced on the project in August 1959 and was completed by mid 1960. The creek was realigned, moving it away from the houses that were endangered on Hilda Street (Plate 5-4). The new channel was constructed with a 20 ft-wide concrete invert, and the toes of the banks were lined with bluestone pitchers (Fig 5-6). The channel banks were shaped to a slope of  $1\frac{1}{2}$  to 1, filling being added where necessary. The appearance of the section in August 1960, immediately after construction, is shown in Plate 5-3C and D, while Plate 5-3E and F shows the channel in 1980.

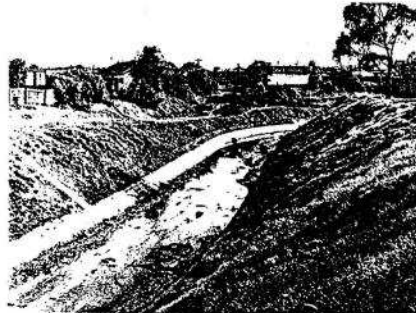
D View looking upstream in 1960 immediately after completion of improvement works

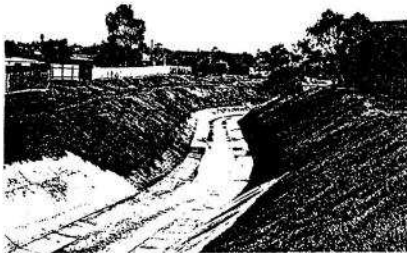
E The same view as in C in 1980

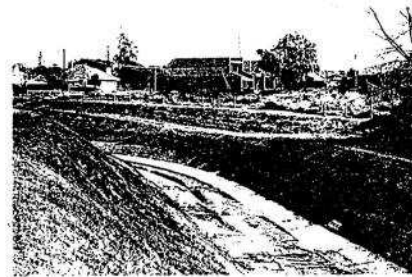
F The same view as in D in 1980

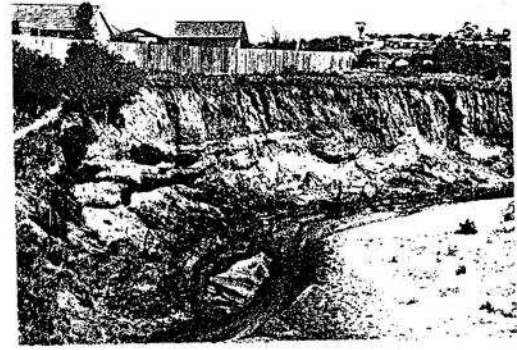
- (c) **Improvements at Somerset Street, Coburg.** Between 1940 and 1958 a strip of land up to 40 feet wide was eroded from the outside of a bend of Moonee Ponds Creek immediately downstream of the Gaffney Street Footbridge in Pascoe Vale (Fig 5-8). By 1958 the east bank had migrated to within a few feet of the back fences of properties in Somerset Street (Plates 5-6A and 5-7A). Quite understandably, the Board of Works received a number of requests from the property owners for protection works to be undertaken.

A Bank erosion, 1955

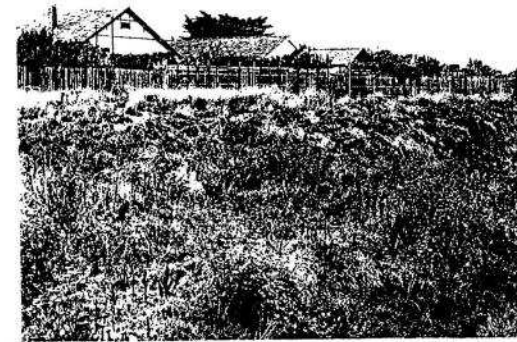
Within four years of the completion of the works, considerable quantities of silt had been deposited in the new channel and weed growth on the depositional material was prolific (Plate 5-6B). The siltation was almost certainly caused by ponding during flood flows, the watercourse downstream of the improved section being of inadequate capacity. The lined section of the creek was subsequently cleaned out and the weed growth and silt removed from the banks (Plate 5-6C). In late 1975, the section was further modified when it was incorporated into the improvement works undertaken between Gaffney Street and Margaret Street (see Section 8-4). The invert was concrete lined, the bluestone pitchers were replaced by concrete, and an access ramp was constructed (Plate 5-6D).

B The silted, weed-infested improved channel in 1966. The bluestone pitchers are just visible

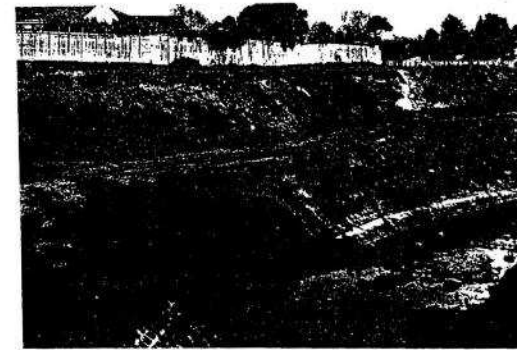
C The cleaned-out channel in early 1975

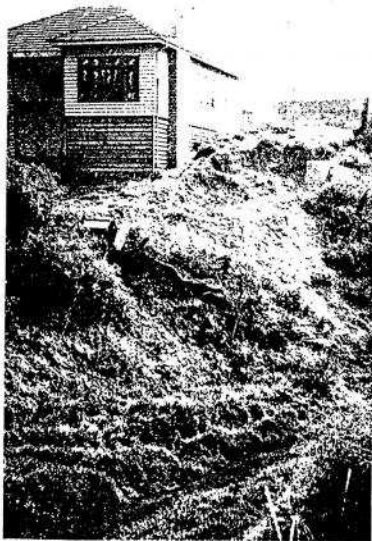
PLATE 5-10 House sited near the bank edge, Morrow Street, Brunswick

at the end of Morrow Street was perilously close to the actively eroding bank of the creek (Plates 5-10 and 5-11A). Quite severe erosion accompanied the flood of 1960, and the residents of Donald Avenue forwarded a petition to the State Rivers and Water Supply Commission, who forwarded it to the Board of Works. The Board decided that improvement works were urgently required between Morrow Street and Vanberg Road, but the job was not issued to construction until June, 1963. The delay was due to the time required to obtain land necessary for the works from a number of property owners (Fig 5-12A).

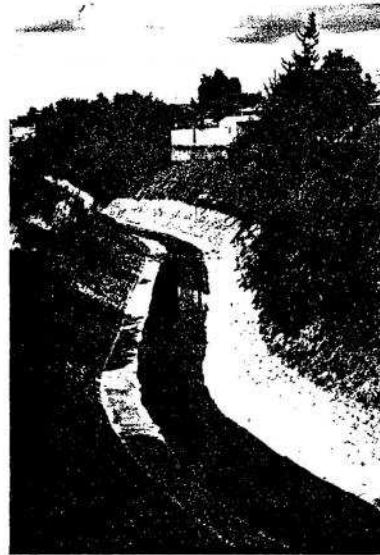
The new channel was slightly realigned (Plate 5-11), moving it away from the rear of the allotments along Donald Avenue. The invert was concrete lined and the lower banks pitched (Fig 5-12). A considerable quantity of fill was required along the Essendon side of the new channel. The incised nature of this section of the creek makes access for machinery difficult; this hindered construction, and makes maintenance difficult (see Plate 5-12).

PLATE 5-12 Improvements at Donald Avenue: View looking downstream from Morrow Street in March 1980
